CHRIST CHURCH
ALEXANDRIA
CHURCHYARD WALL

1978

ON-SITE RESEARCH

Existing Conditions

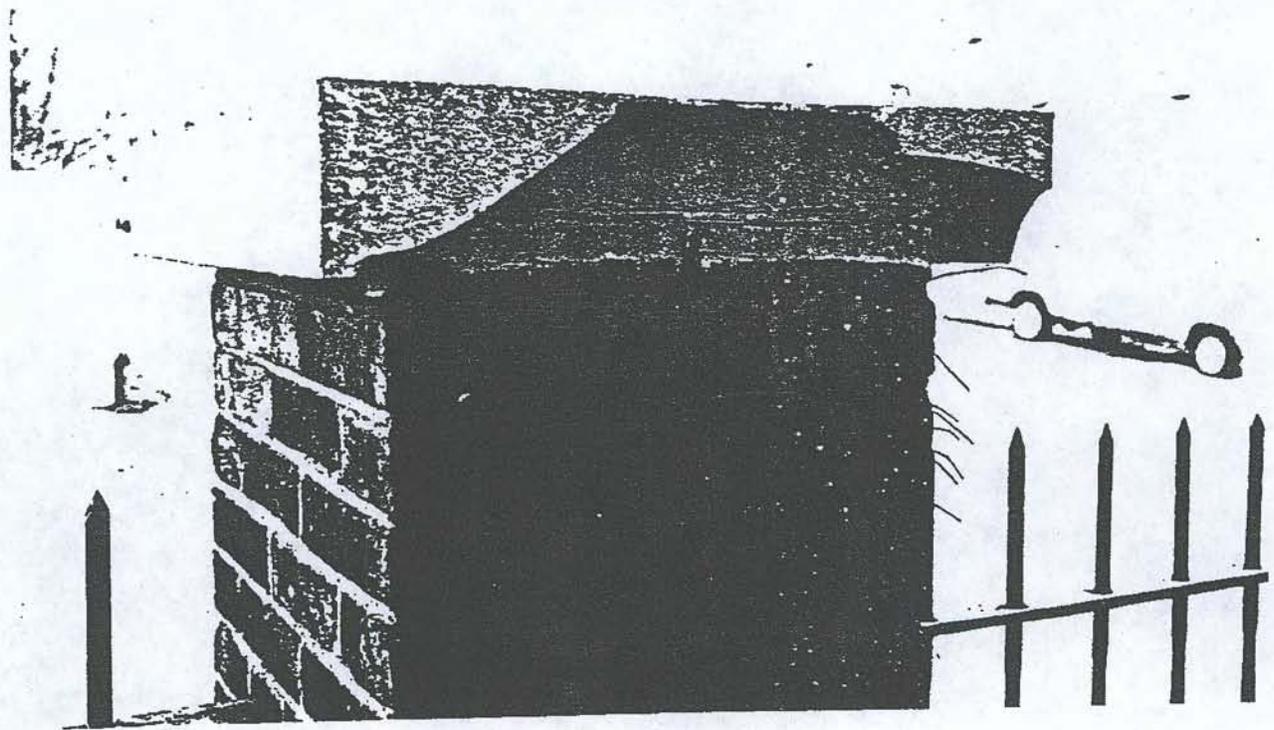
Plate 7

The iron railings and the cast-iron pier caps are generally in good repair. (The cast-iron cap at bay 34 is broken. Two caps at bay 61, adjacent to the entrance gate to the old parish hall, are missing. Substitute plywood caps presently cover these piers.) The gates in the main portals are seriously deteriorated. Lacking proper application of paint and rust deterrents, total elements of the gates have deteriorated. While these cast-iron features can be salvaged, the frame which holds the various panels and elements in place will require replacement (Plate 14). The remaining gates of lesser significance, that is, those at service entrances and the old parish hall, are an important part of the total and should be repaired and maintained.

Detail of Typical Cast-Iron Cap located at Bay 34
The Top of the Cap is Molded to Shed Water

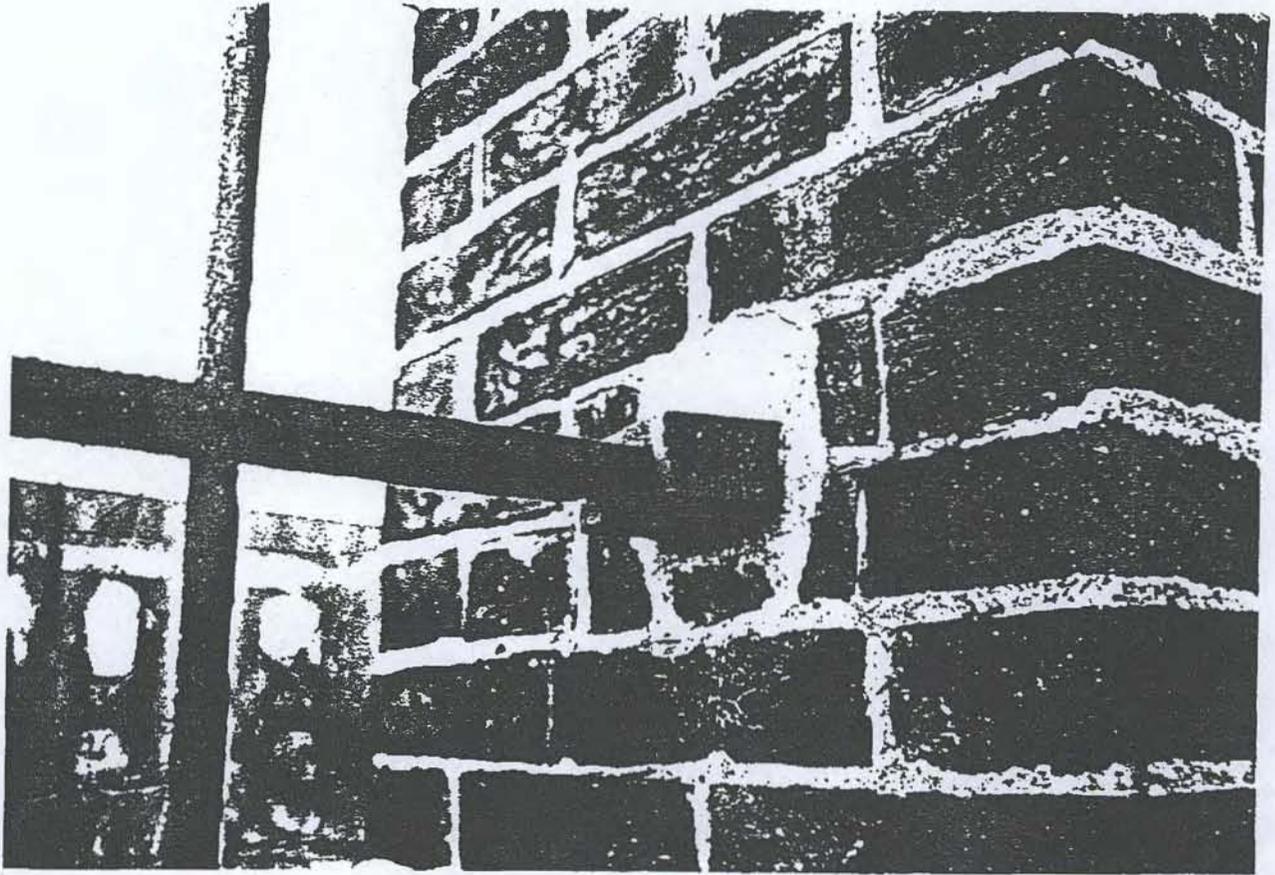
Plate 8

Detail of Cast-Iron Sleeve (Atypically Installed)
Typical Condition is with the Sleeve set Flush to the Pier

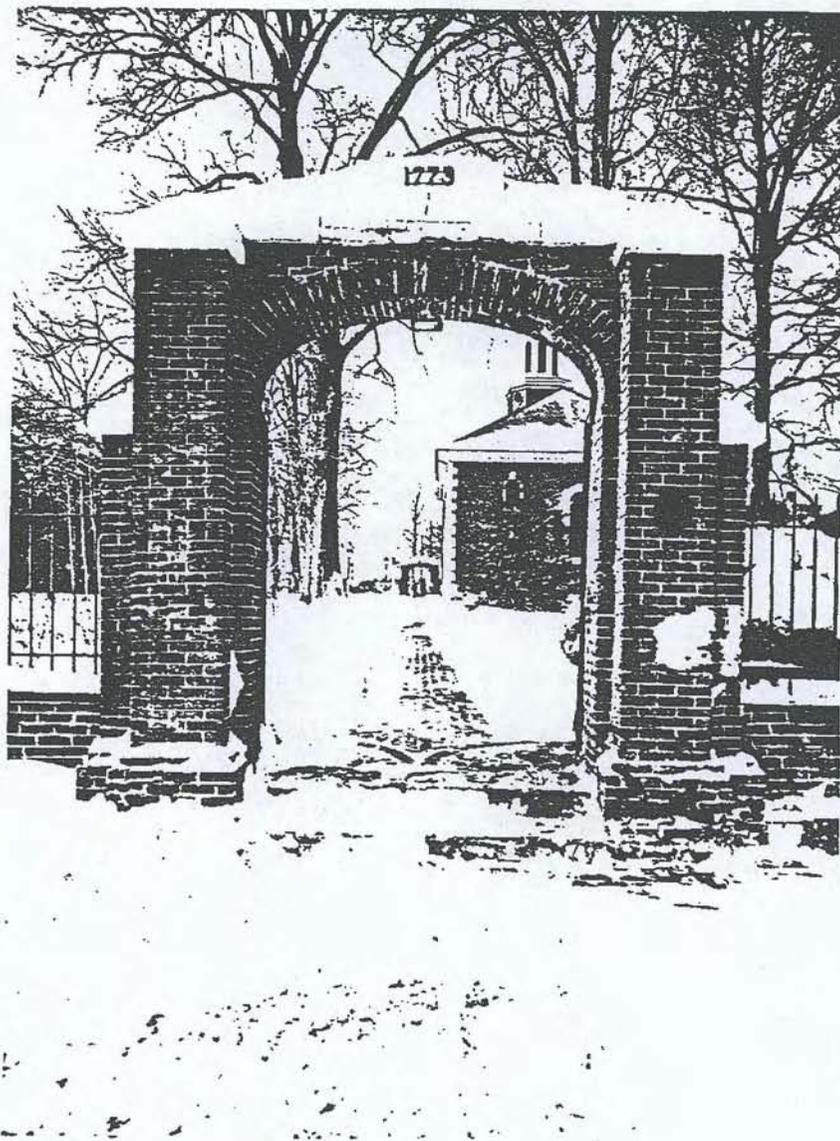
Plate 9

Entrance Portal on East Washington Street Elevation
Note there are Two Steps from the Street Level to the
Churchyard Level. The Lower Step is Concrete and appears to
have been Installed at a Later Date due to a Change in Street Level

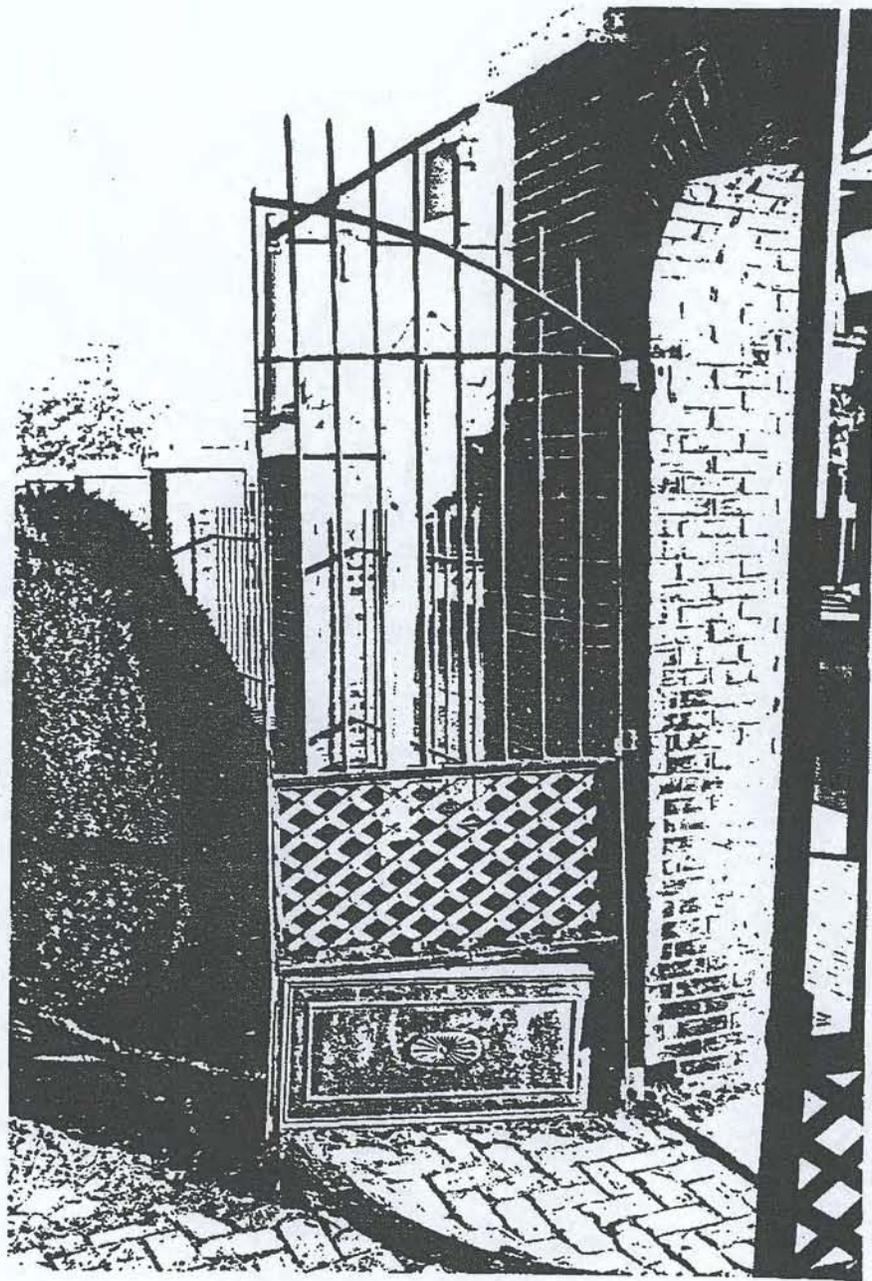
Plate 10

The Base Panel is Cast Iron and the Central Panel is Riveted Latticework
The Upper Portion Corresponds to the Adjacent Fence
Note the Tracks Provided on the Ground to Prevent the
Brick Paving from Abrading

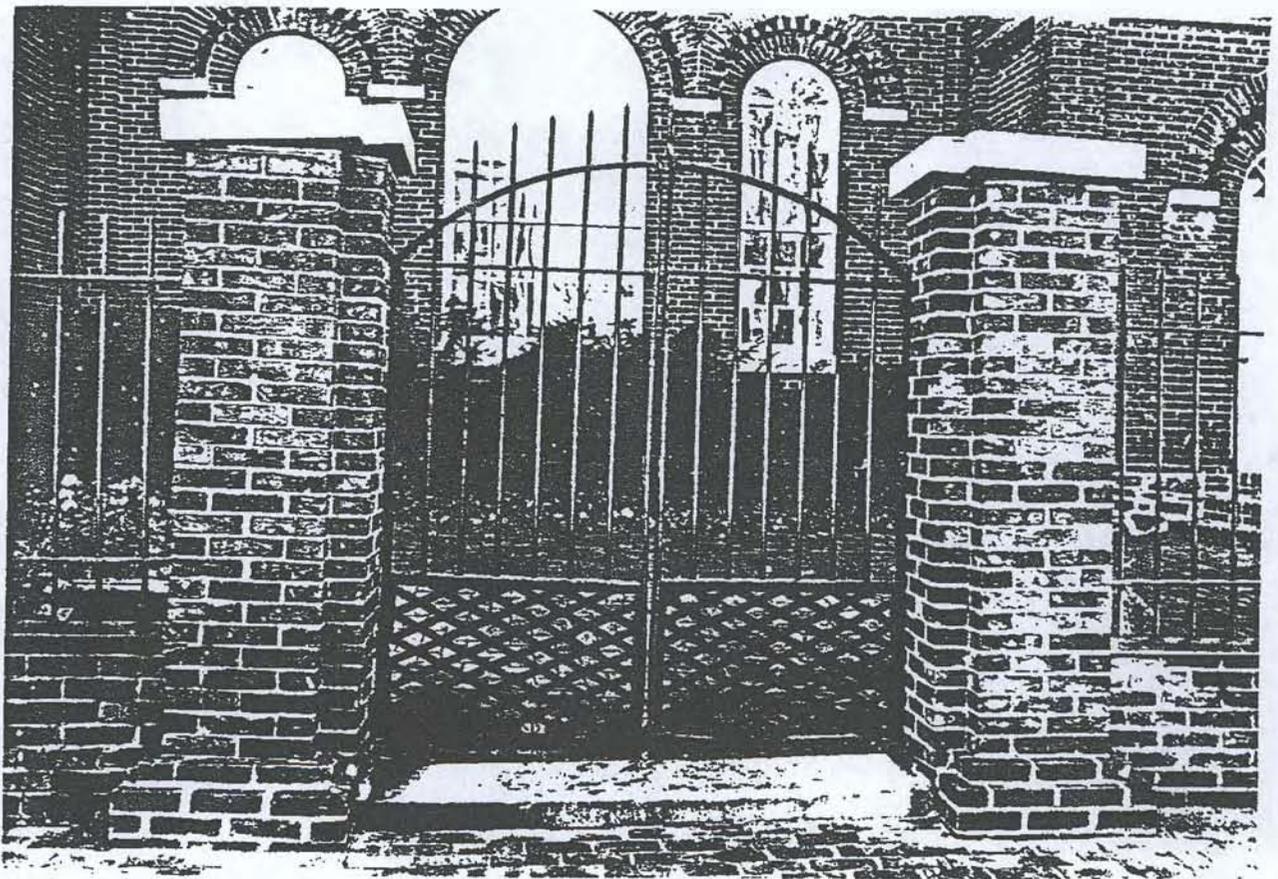
Plate 11

Detail of Entrance Gate to Old Parish Hall
Note the Right Column Cap is a Plywood Replacement

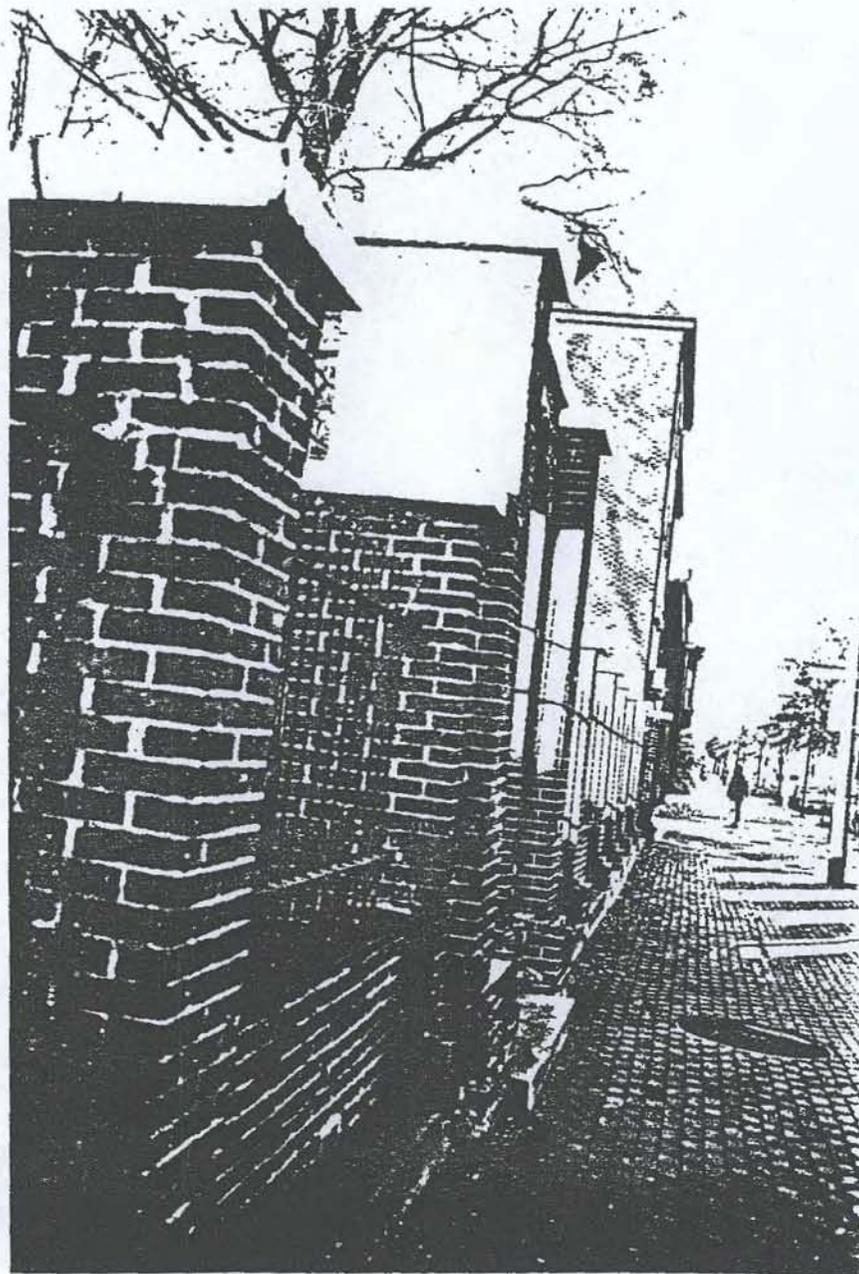
Plate 12

require basic repairs such as repointing. More serious problems occur in lengthy segments of the wall which are presently leaning, probably because of the ground mass behind the wall and inadequate foundations. In areas where the wall has heaved, particularly in the northeast corner of the churchyard, reconstruction will probably be required (Plate 12). Additional work will be required along Washington Street where the wall has been underpinned with an inappropriate concrete curb.

View of a Segment of the East Wall
Note the Leaning Pier at Northeast (far) Corner

Although extensive repairs including the underpinning of certain sections will be required if the wall is to be retained, such investment will preserve a wall whose design and construction were established 150 years ago as a suitable enclosure for the landmark church and its historic yard.

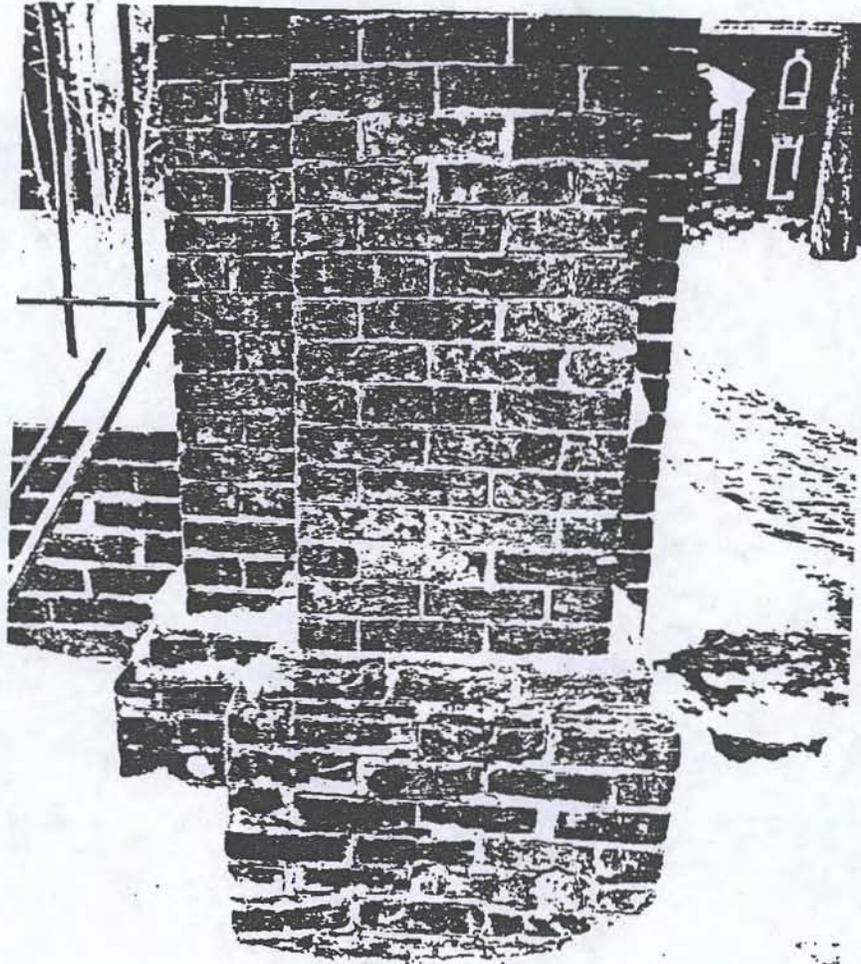
Plate 13

There is some brick deterioration present; however, the major problems seem to be associated with settlement and deterioration of the pier bases (Plate 13). This condition is most evident on the Cameron Street elevation.

Detail of the Base of a Corner Pier
Note Deteriorated Condition of Pointing and Associated Settlement

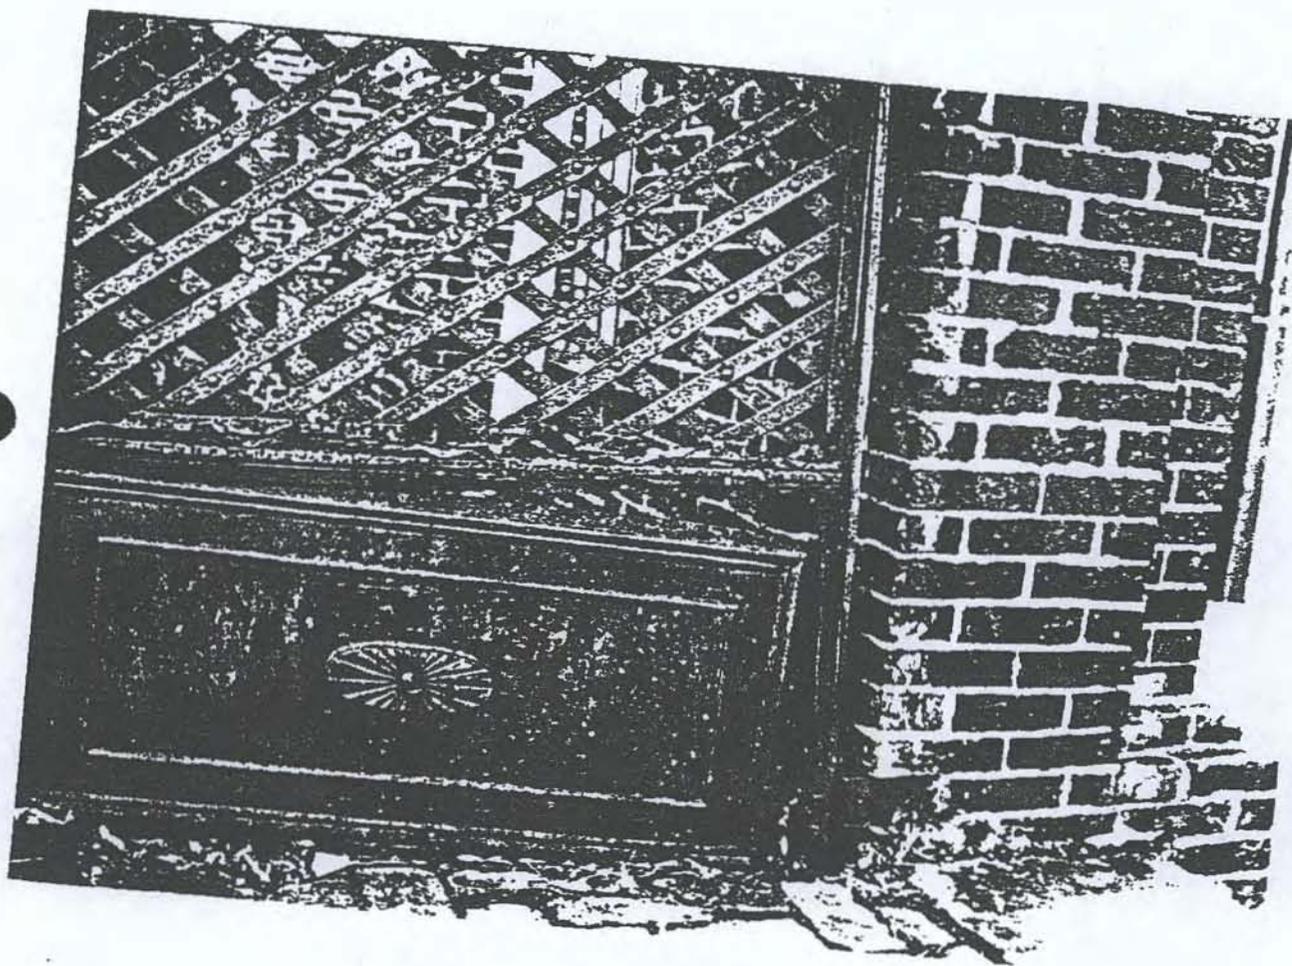
Plate 14
Detail of Iron Gate Showing Deteriorated Members and
Dropped Cast-Iron Panel

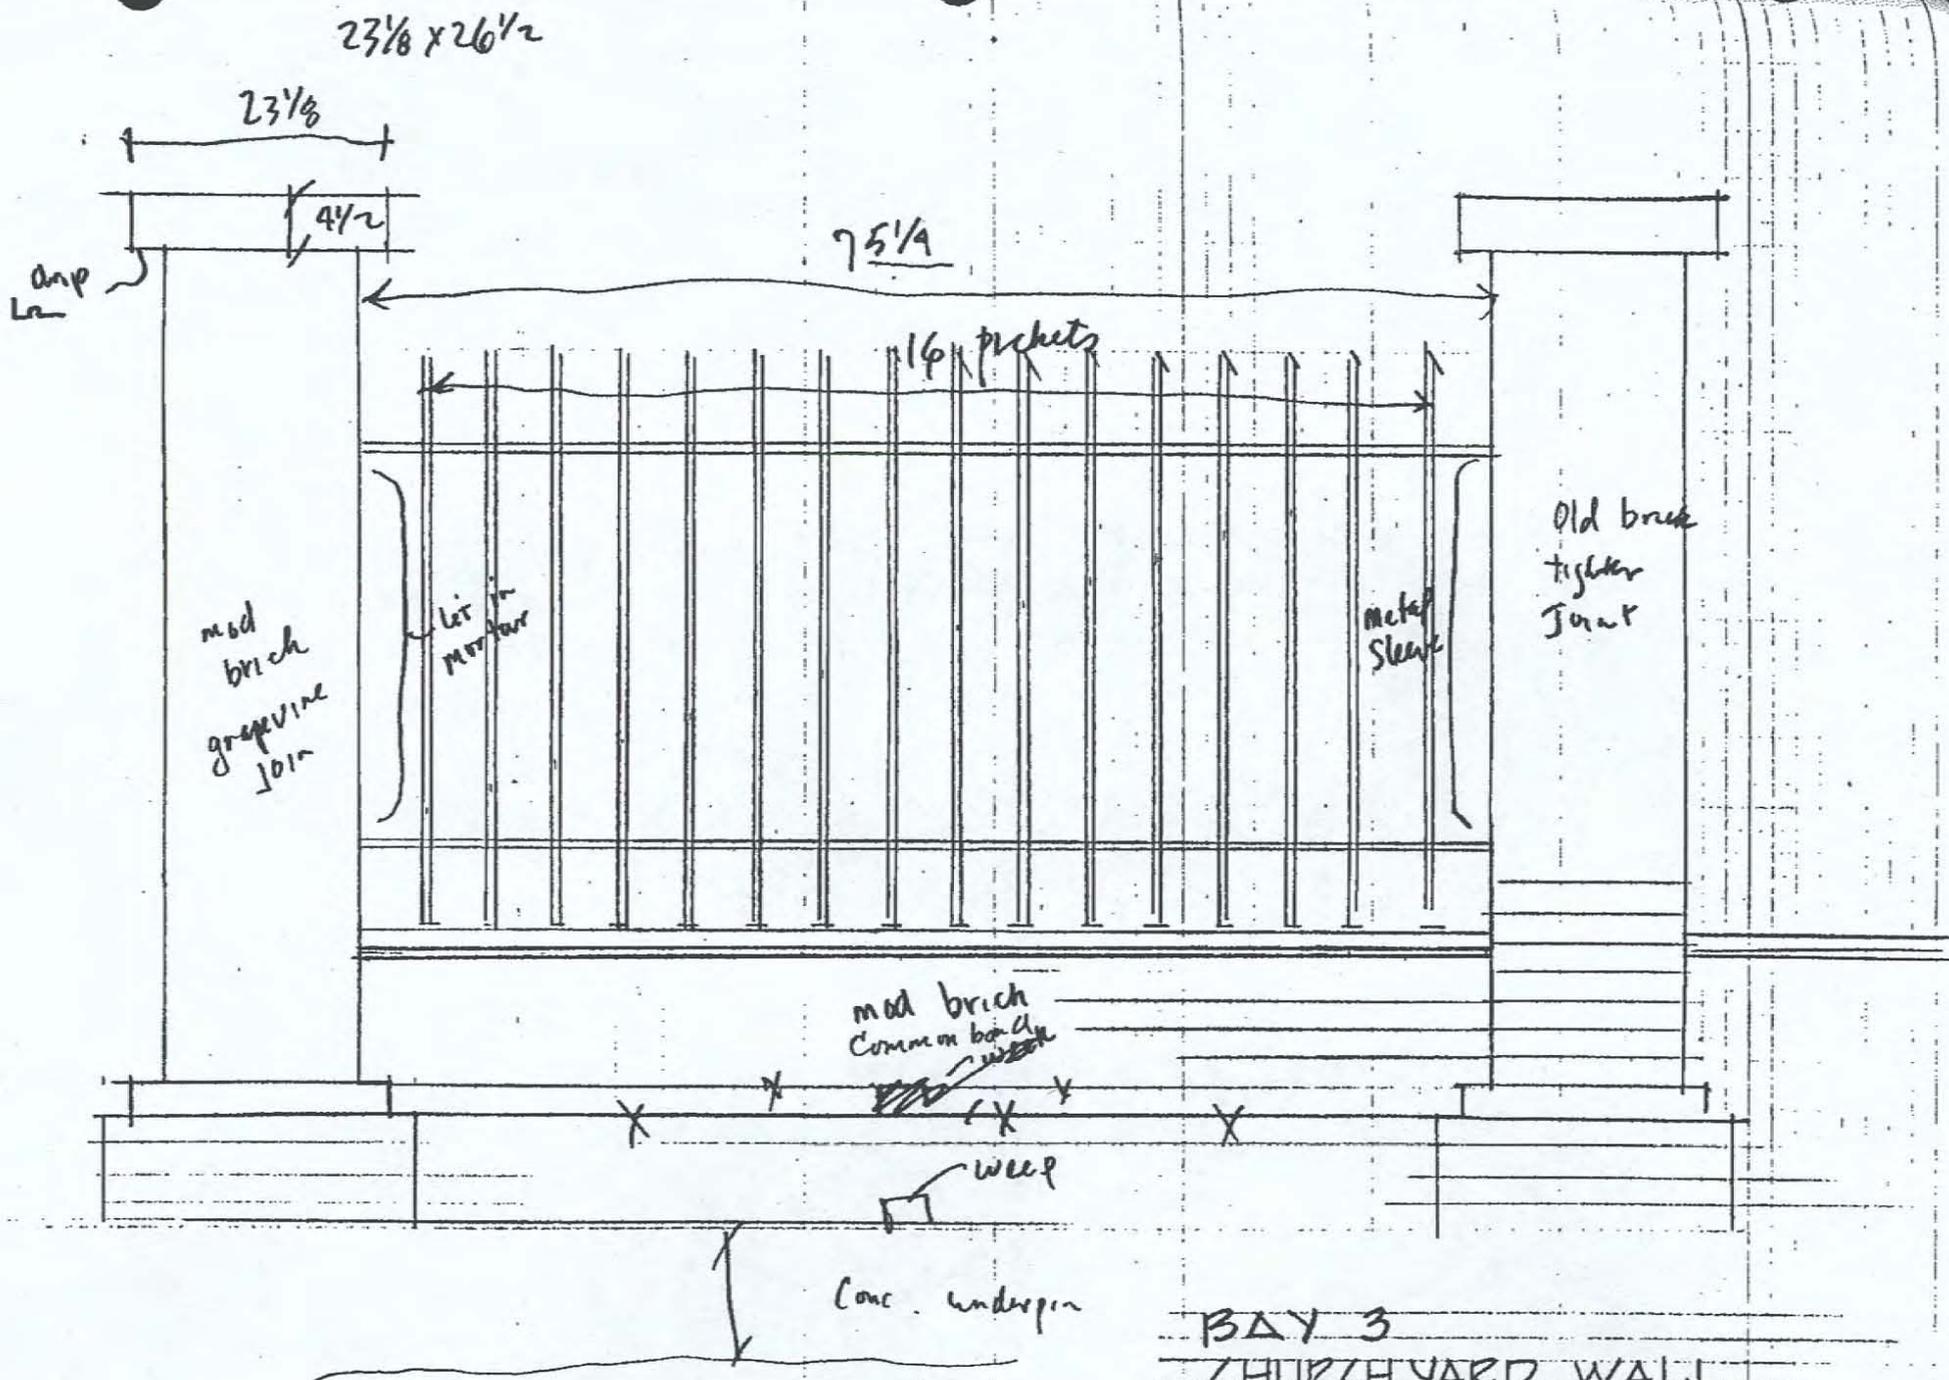
BAY 3

old brick
tighter joint

cut grapevine
lime mortar

let in
w/ iron
sleeve

no grapevine
slightly wider joint
8 1/4 x 8 1/2 - x 2 1/8

conc. underpin

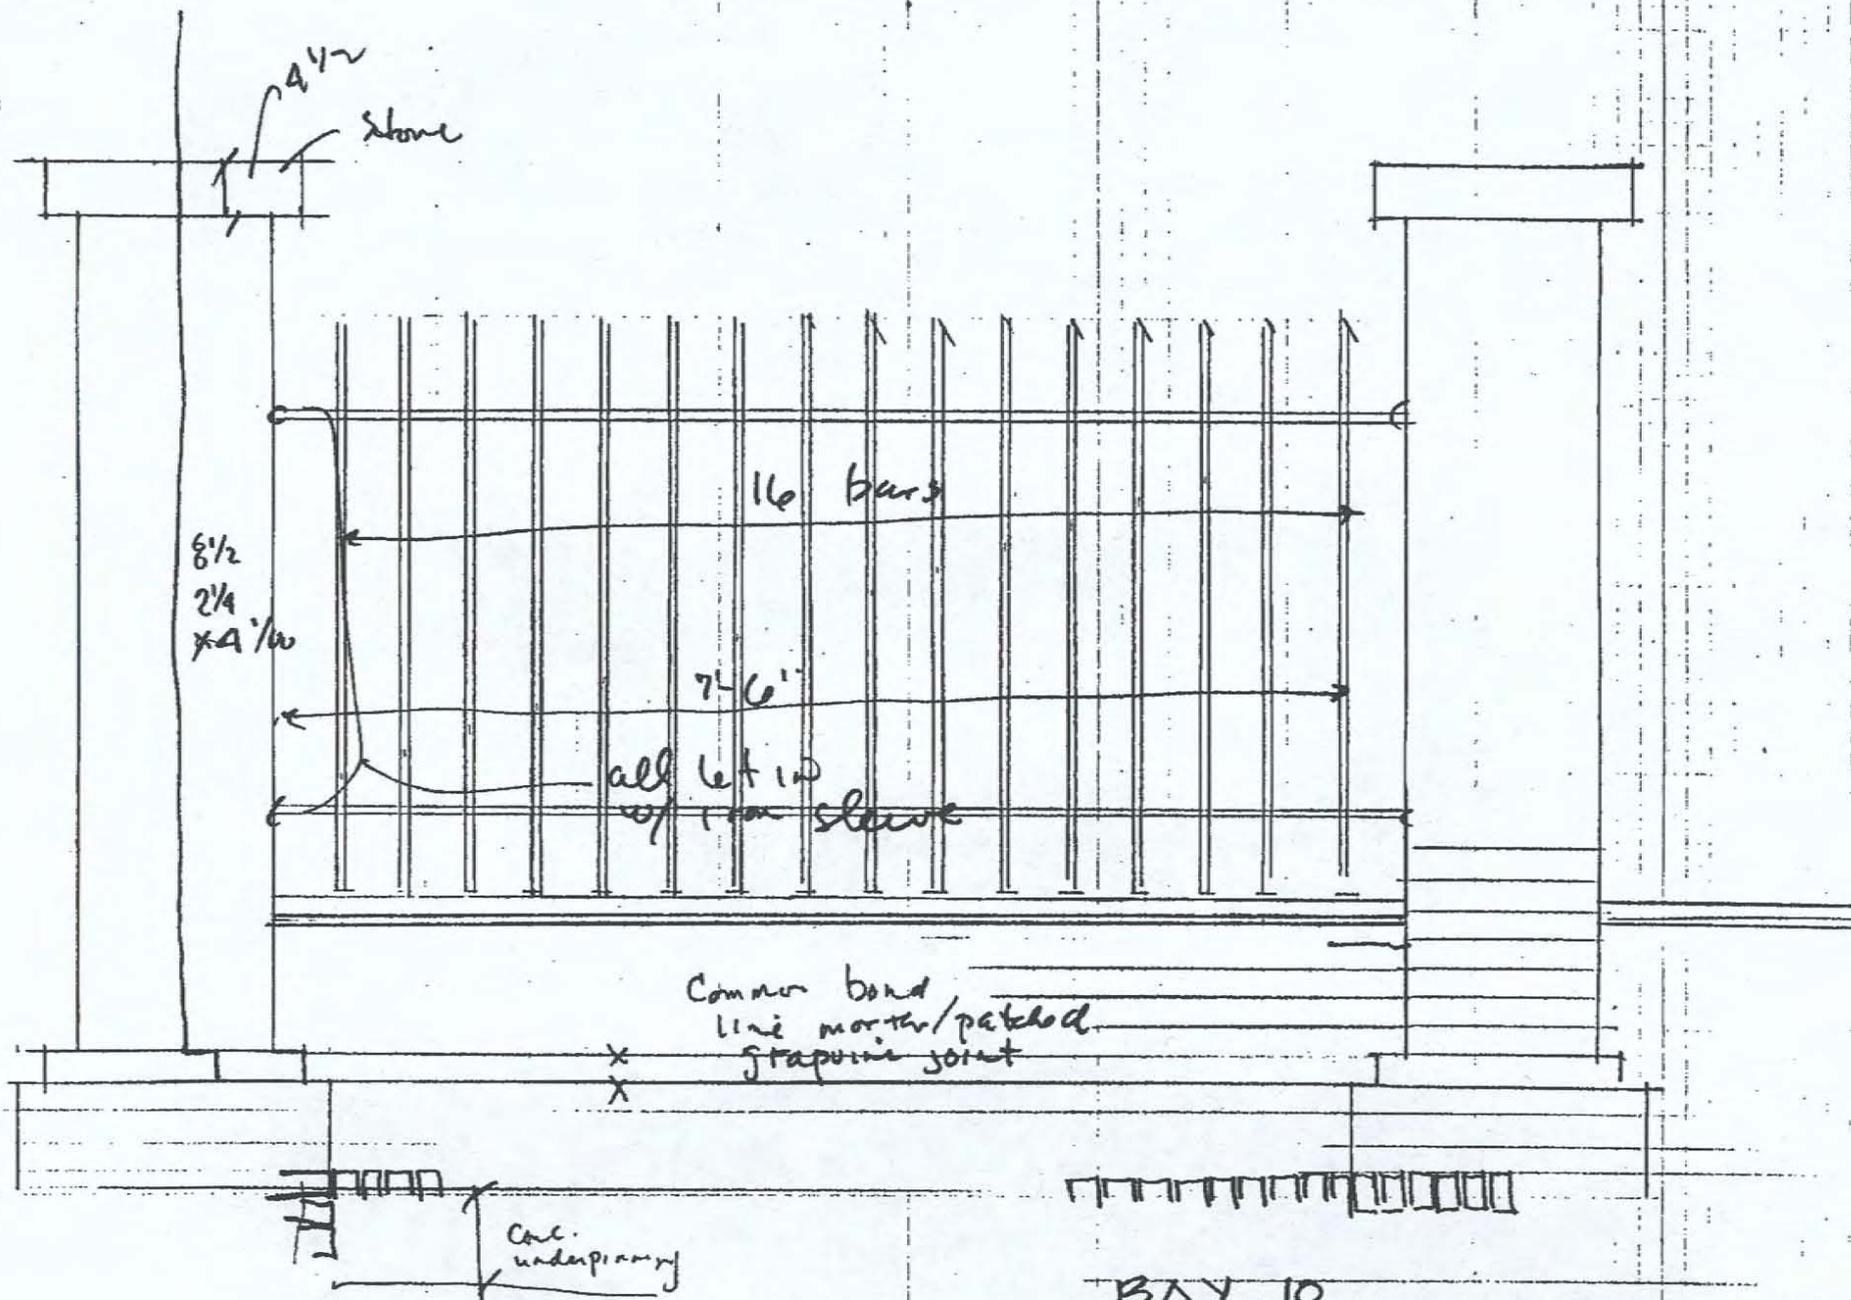
BAY 10
 CHURCHYARD WALL
 CHRIST CHURCH
 ALEXANDRIA, VIRGINIA

all let in
iron sleeve

same
shift
pier

brick
colors
don't
to be later
in fill.

match
to appear
to be later
in fill.

conc. under paving
