HAZARDOUS MATERIAL SURVEY

**ROBINSON TERMINAL/ALEXANDRIA MARINE SHOP
ALEXANDRIA, VIRGINIA**

ECS PROJECT NO. 01:21983-B

OCTOBER 4, 2013

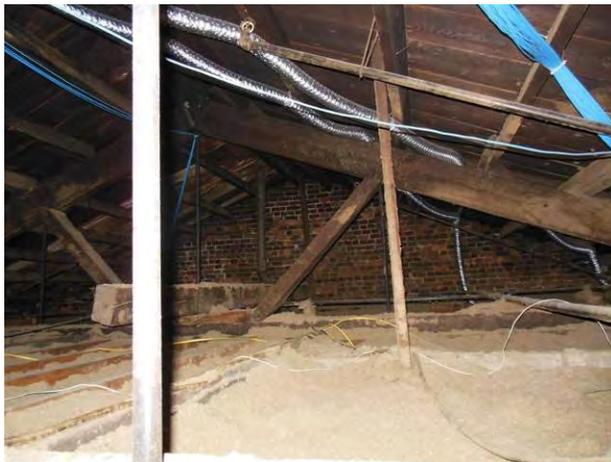
3. View of the attic insulation, Samples 1-3.

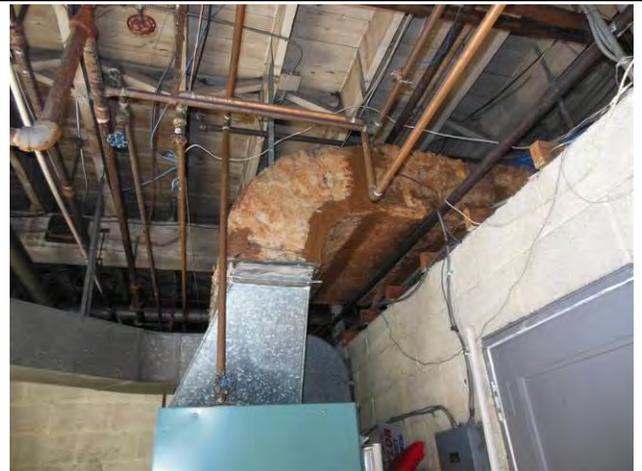
4. View of the brown duct mastic and white vibration cloth, Samples 4-9.

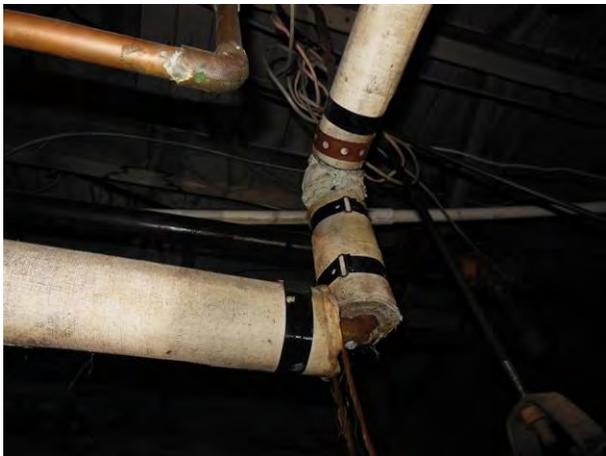
5. View of pipe insulation and hard elbow insulation, Samples 10-15.

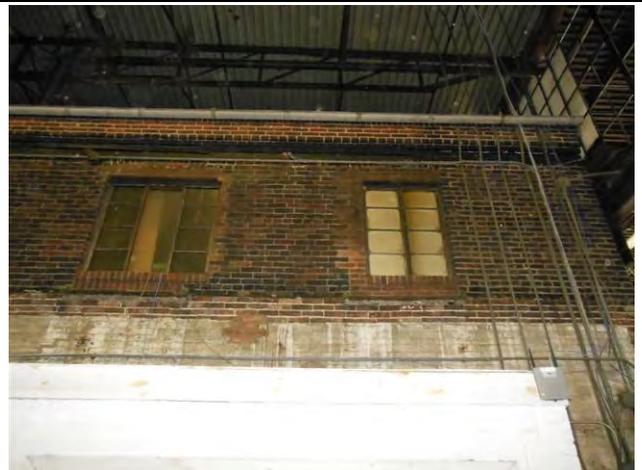
Interior and exterior window caulking throughout the warehouse, and welding shop were typical. The warehouses have upper windows that were inaccessible, but typical of lower windows. The window glazing throughout the structures was observed to be in poor condition (damaged) and in a friable state when touched. This material should be classified as Friable (Photograph Nos. 6 and 12).

6. View of upper portion of office building within the warehouse area with suspect flashing mastic, inaccessible.

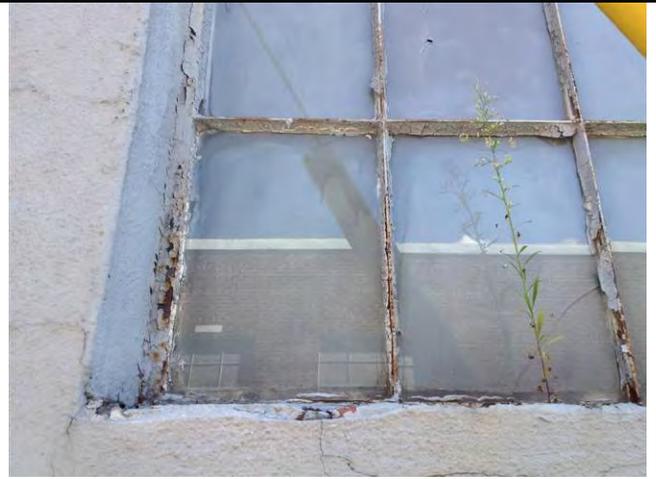
8. View of window caulk, Samples M1-M3.

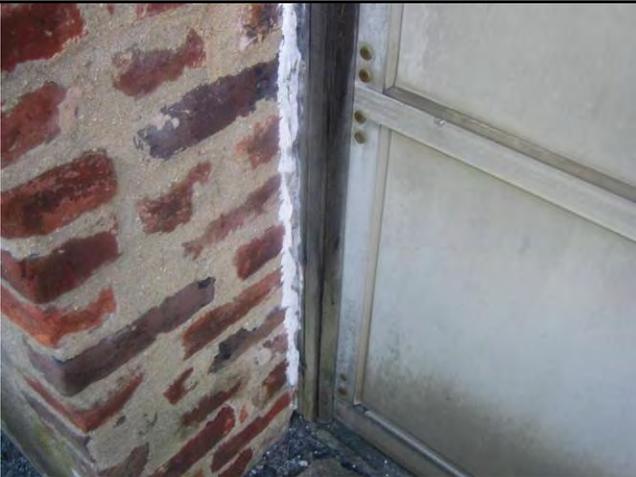
9. View of exterior garage door caulking, Samples M7-M9.

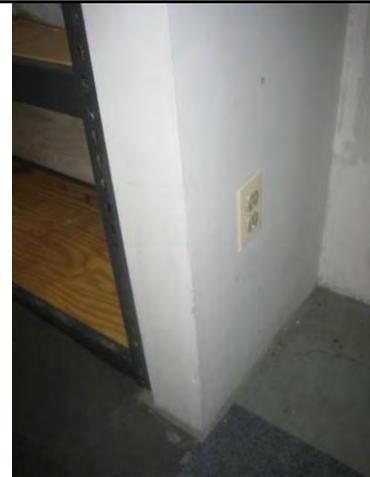
10. View of joint compound, Samples M4-M6, M10-M12.

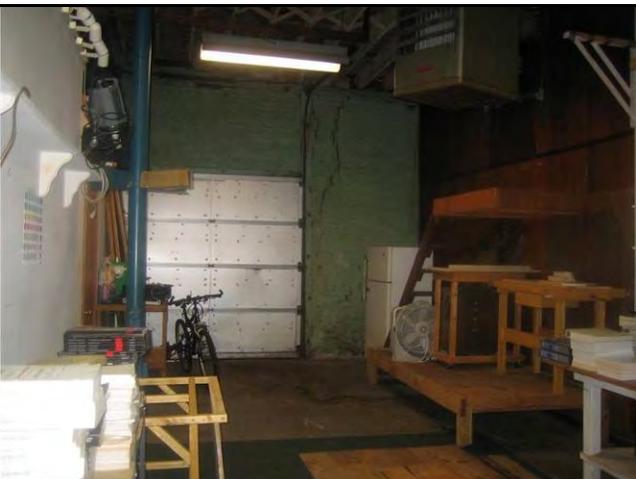
Surfaces throughout the structures appeared to have various painting histories with multiple layers and areas of deterioration. Paint within the warehouse areas, warehouse storage, welding shop, and in the marine shop were observed to be in poor condition.

11. View of rear storage room in Marine Shop with LBP on perimeter wall (green surface color).

At this time ECS recommends that all painted surfaces in the structure be assumed to have detectable levels of lead and are regulated under OSHA. The OSHA standard under 29 CFR 1926.1101 gives no guidance on acceptable levels of lead in paint at which no exposure to airborne lead (above the action or permissible exposure levels) would be

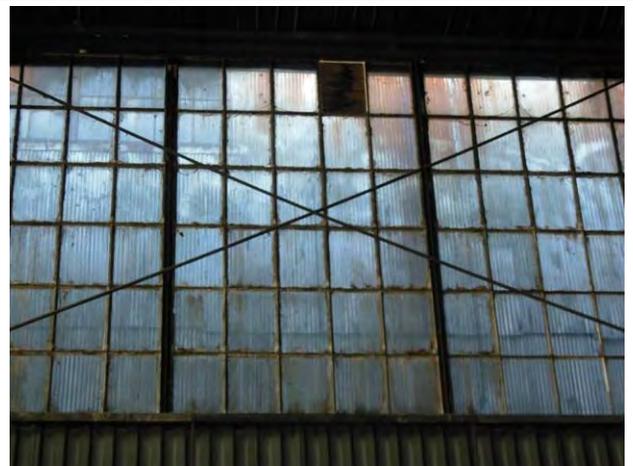
12. View of the upper windows within the warehouse.
