# Can Defects

Examples of damage to metal cans  
and when damage requires return of  
merchandise.

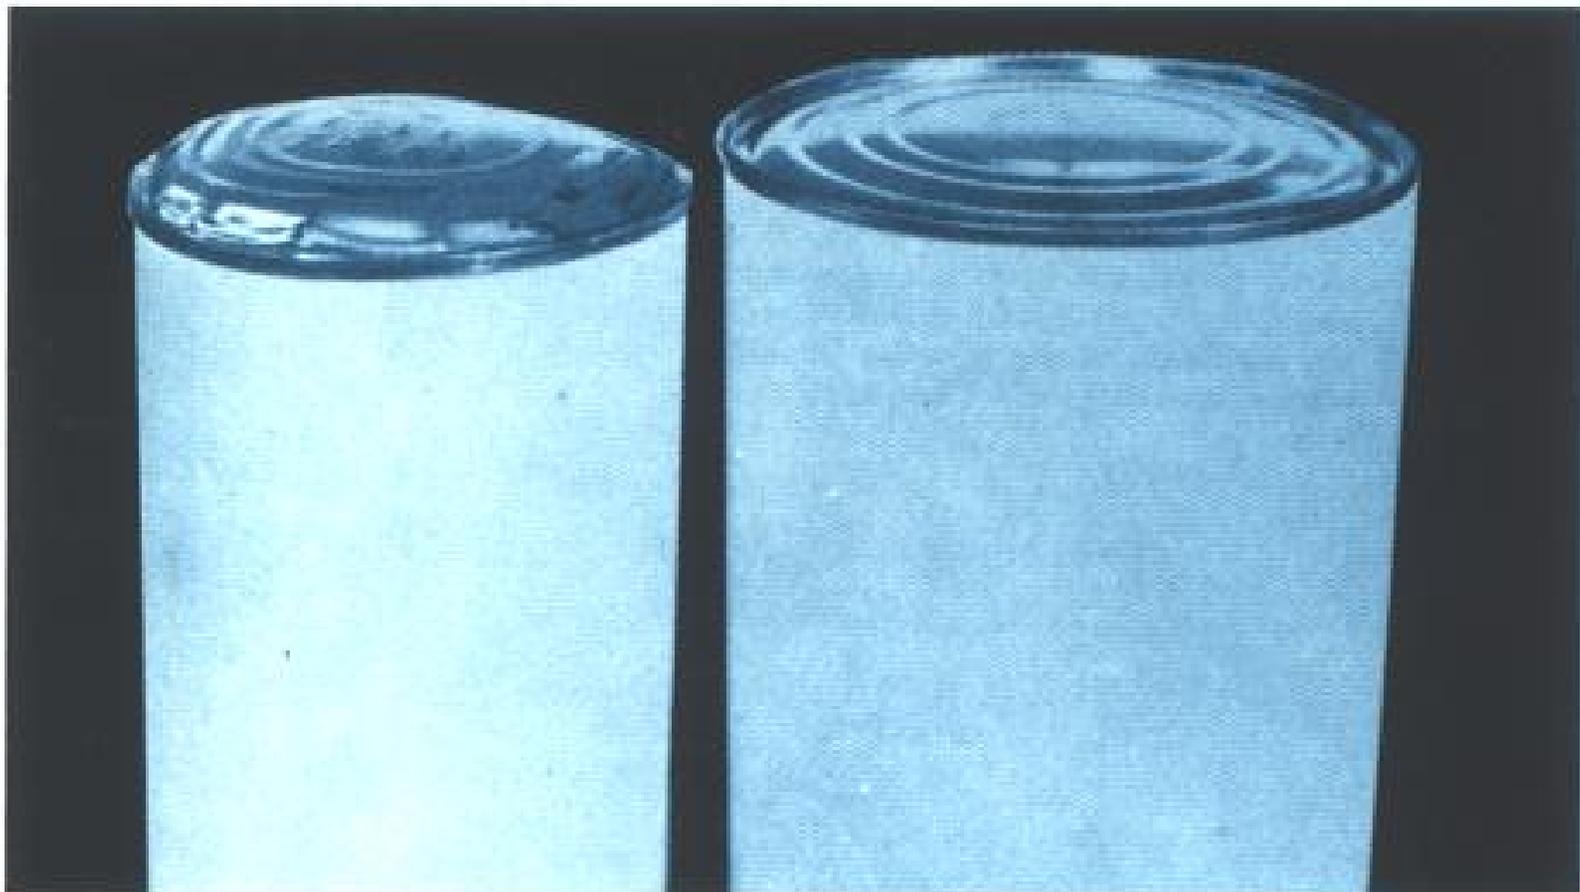
1.

Bulged and/or swollen ends from gas formation in can which causes one or both ends to swell producing a flipper, soft swell, hard swell, or blown can.

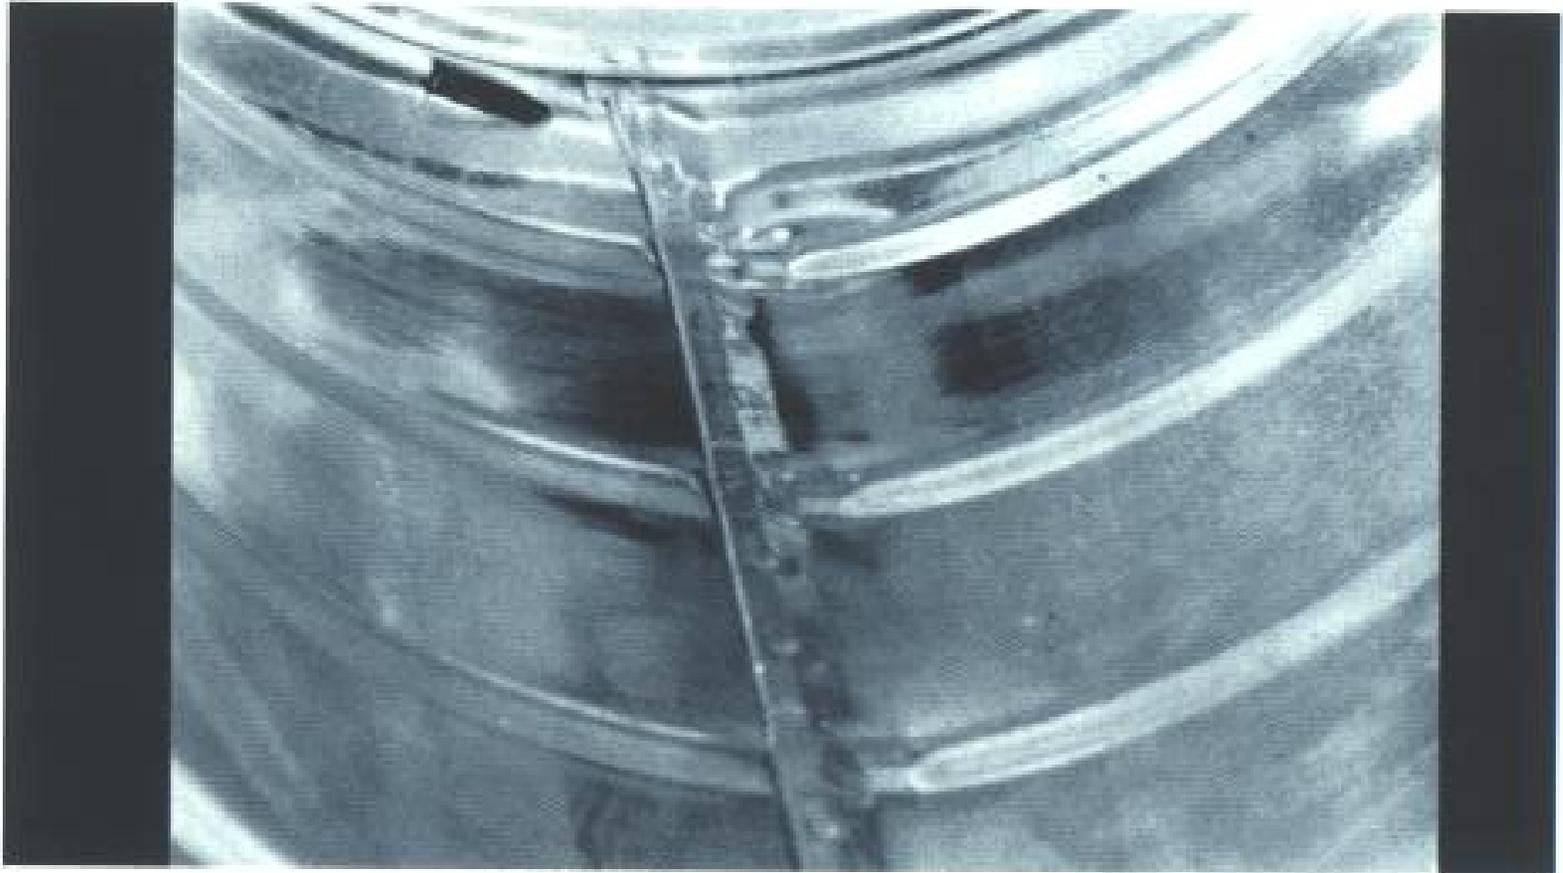
2.

Can with likely loss of hermetic seal and normally a leaker due to the mislocked side seam.

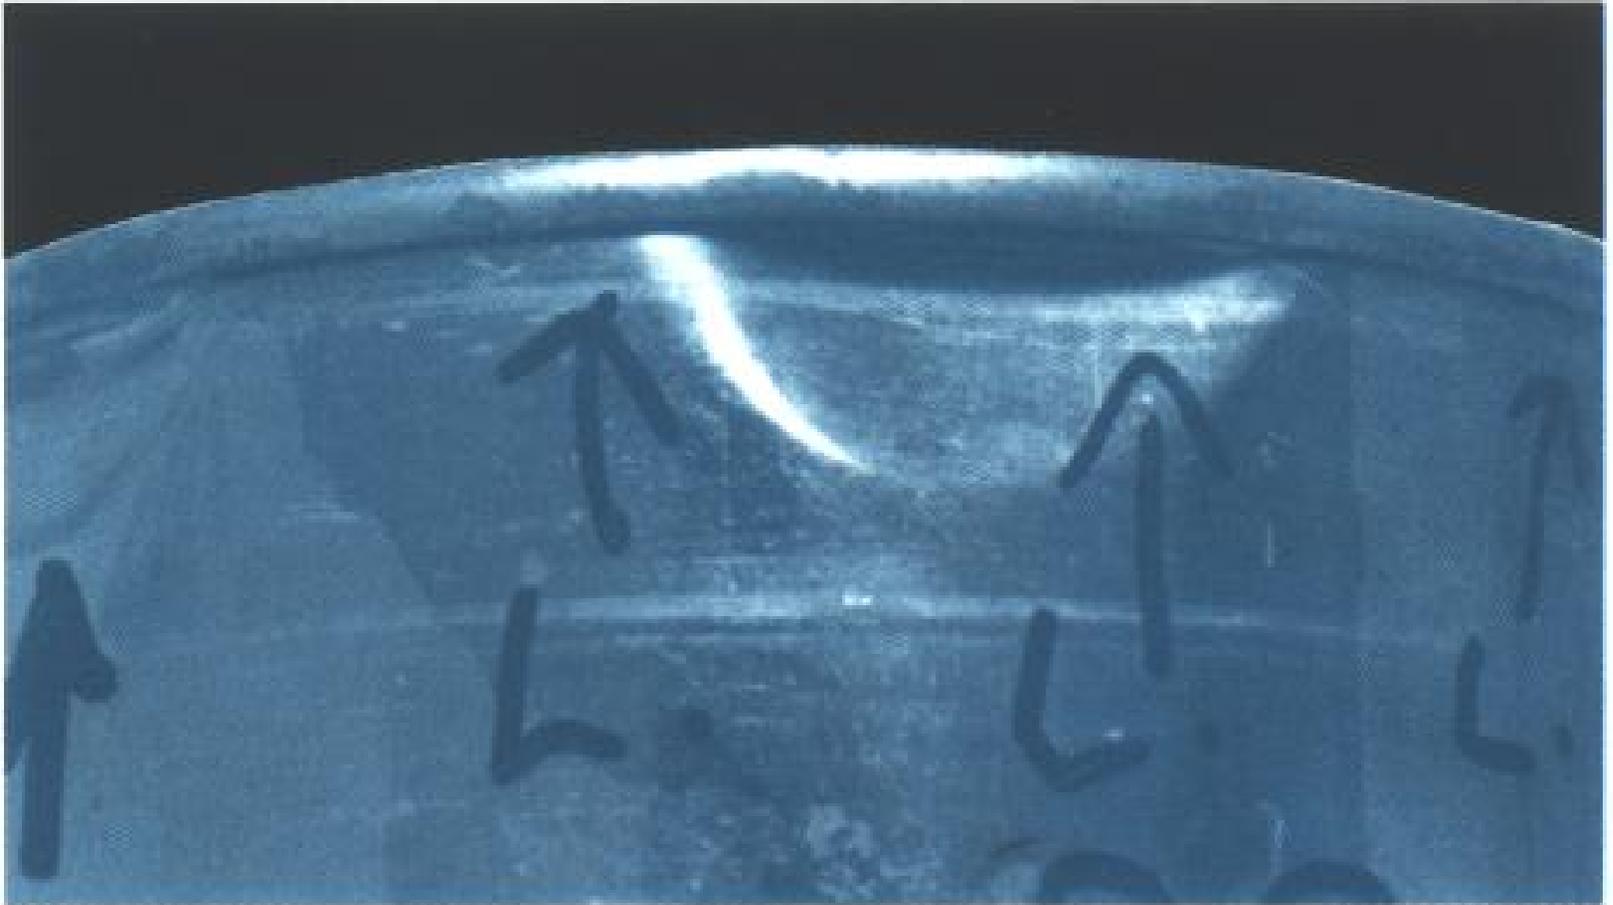
3.

An opening below the double seam or plate fracture.

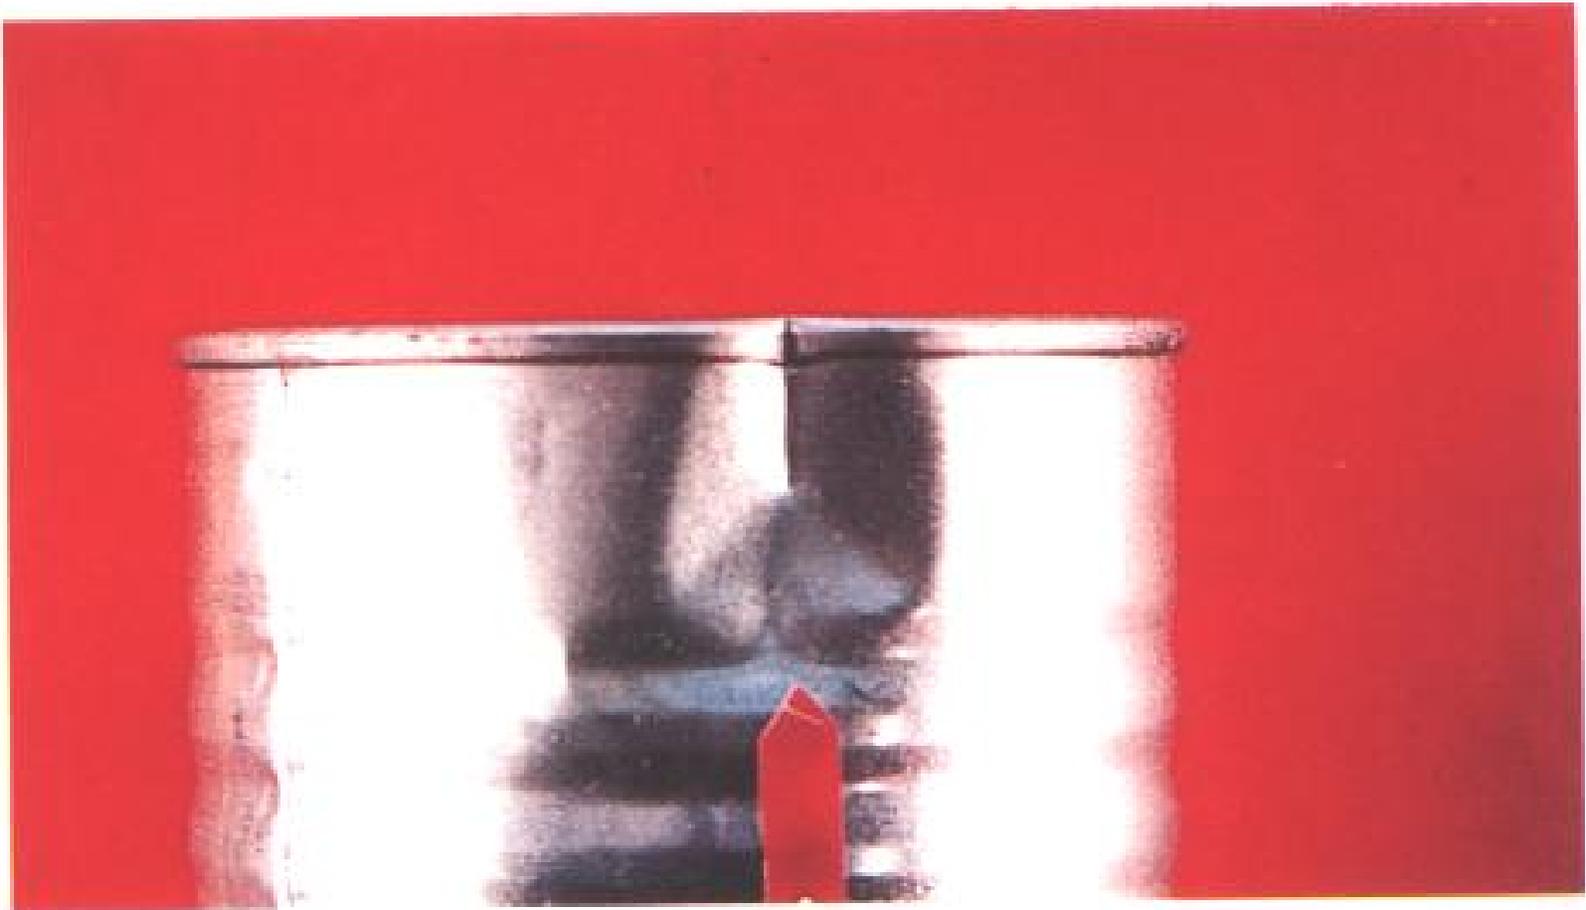
4.

Plate fracture in double seam or can body. (Note position of red pointer).

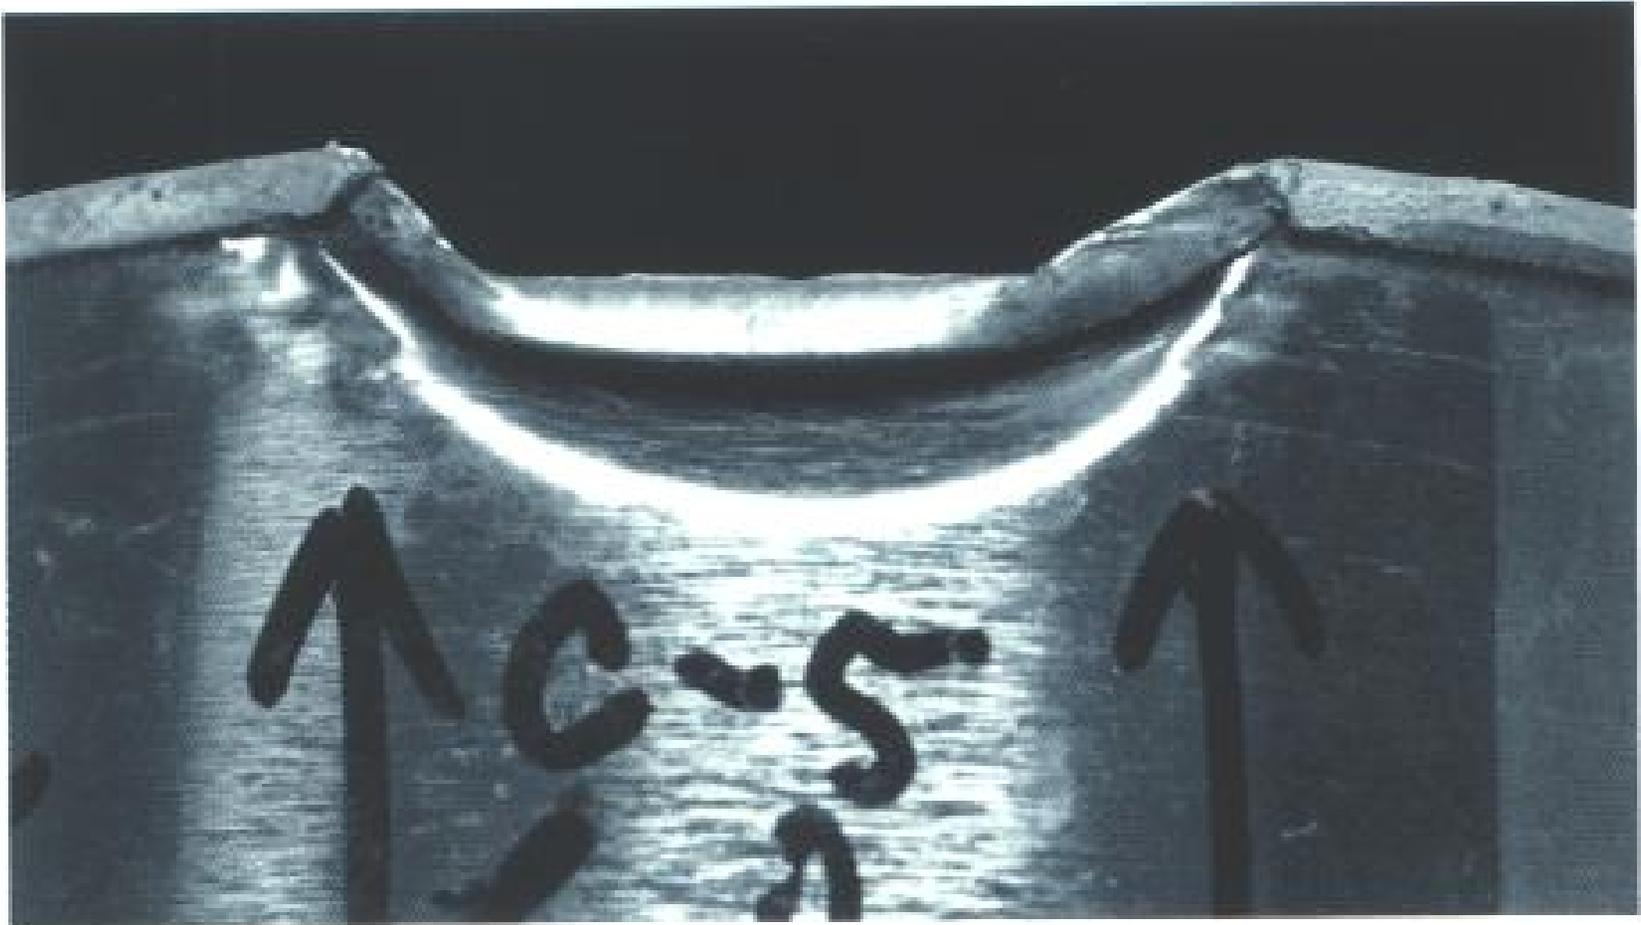
5.

Severe double seam dent plate fracture.

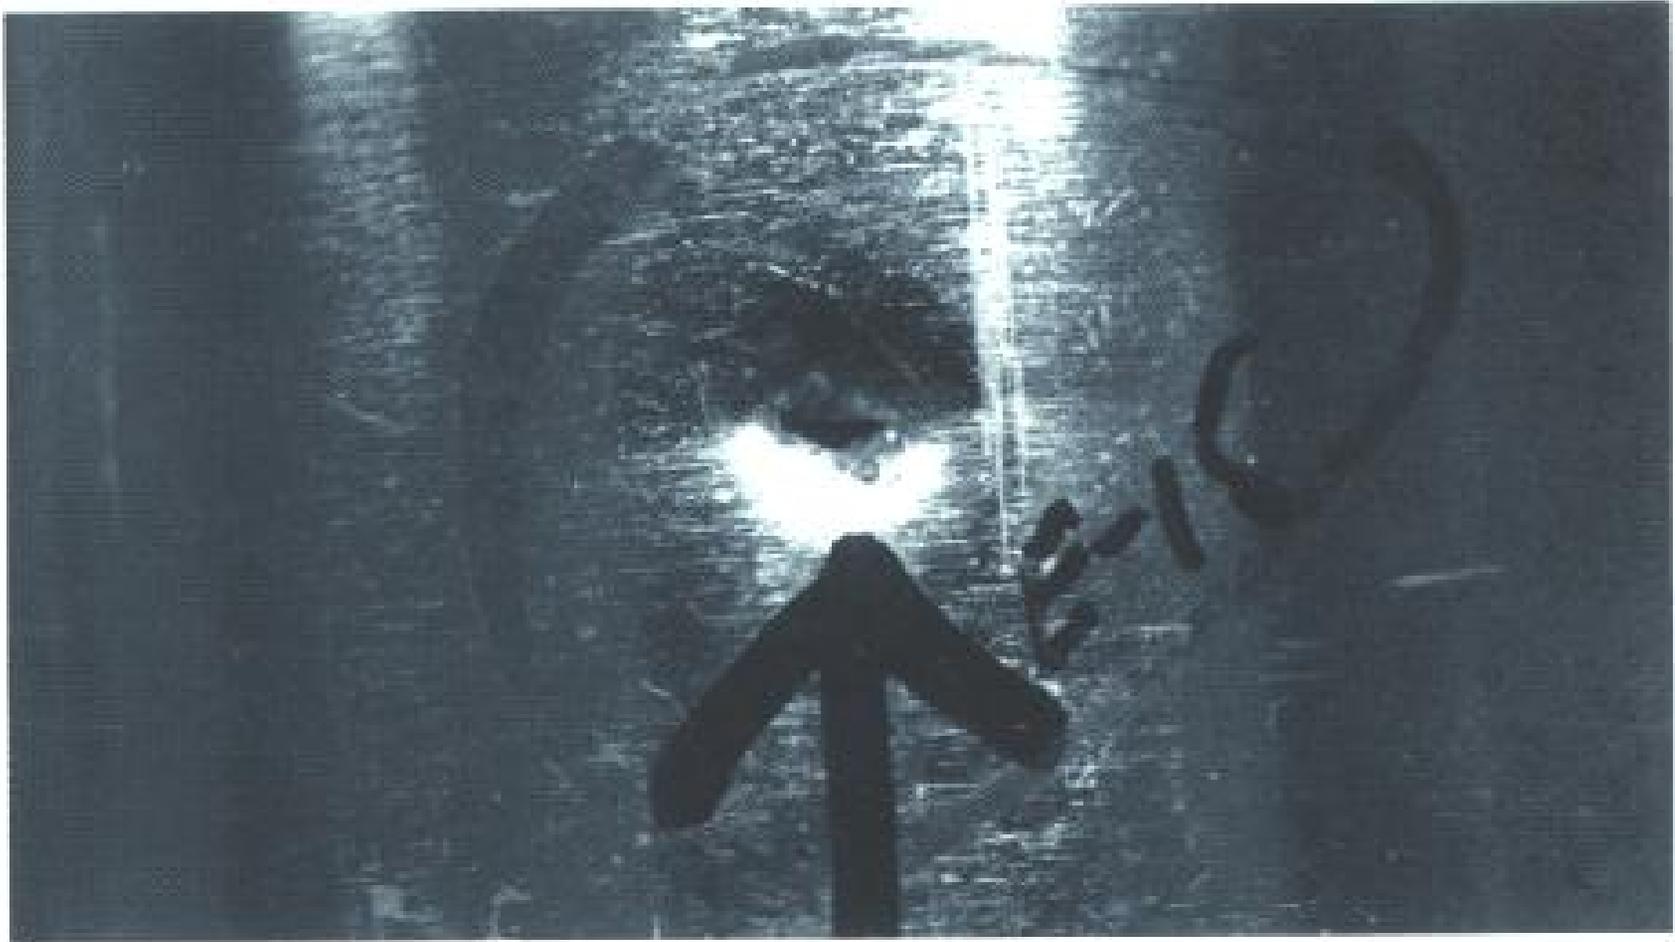
6.

Puncture in can body. Pinholes in can body plate also cause loss of hermetic seal.

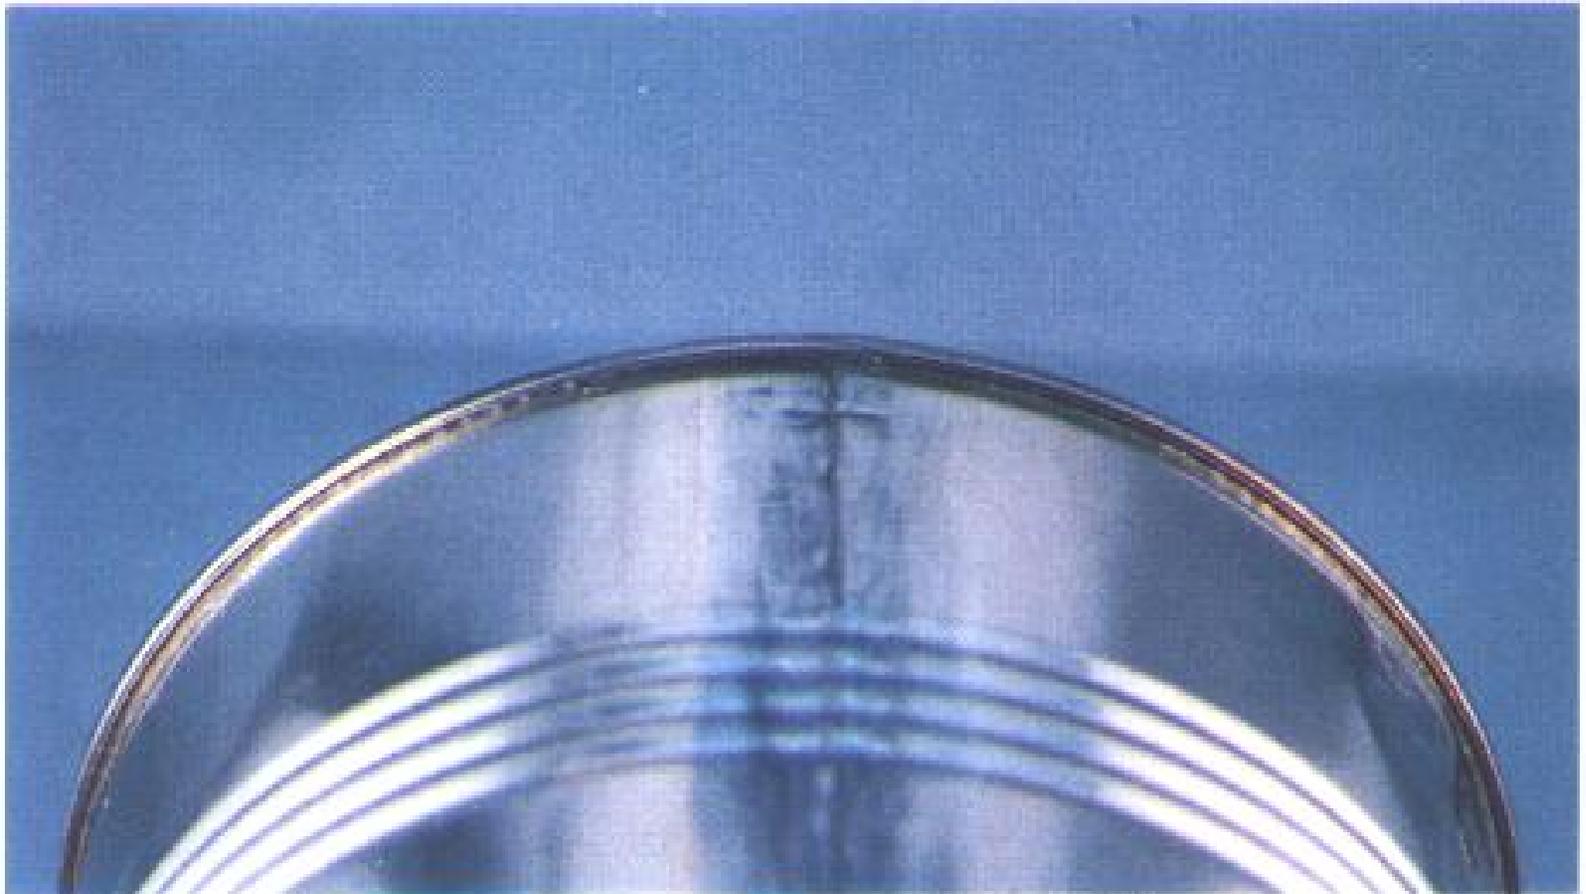
7.

Closure on end of can reflects incomplete double seam (Double seaming operation not completed by manufacturer).

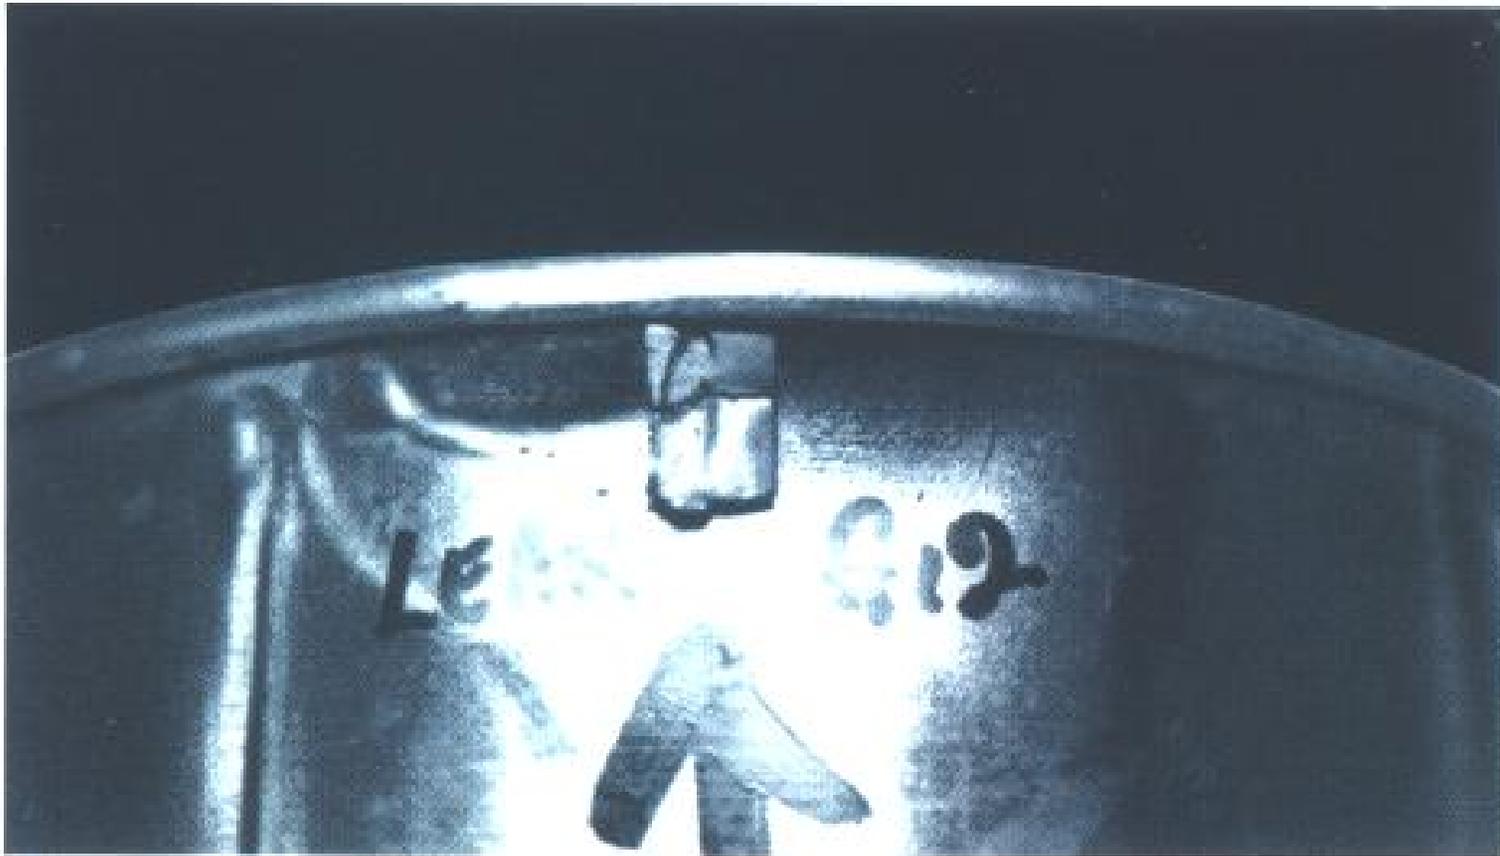
8.

Defect in end of closure on can (torn flange). Note arrow pointer.

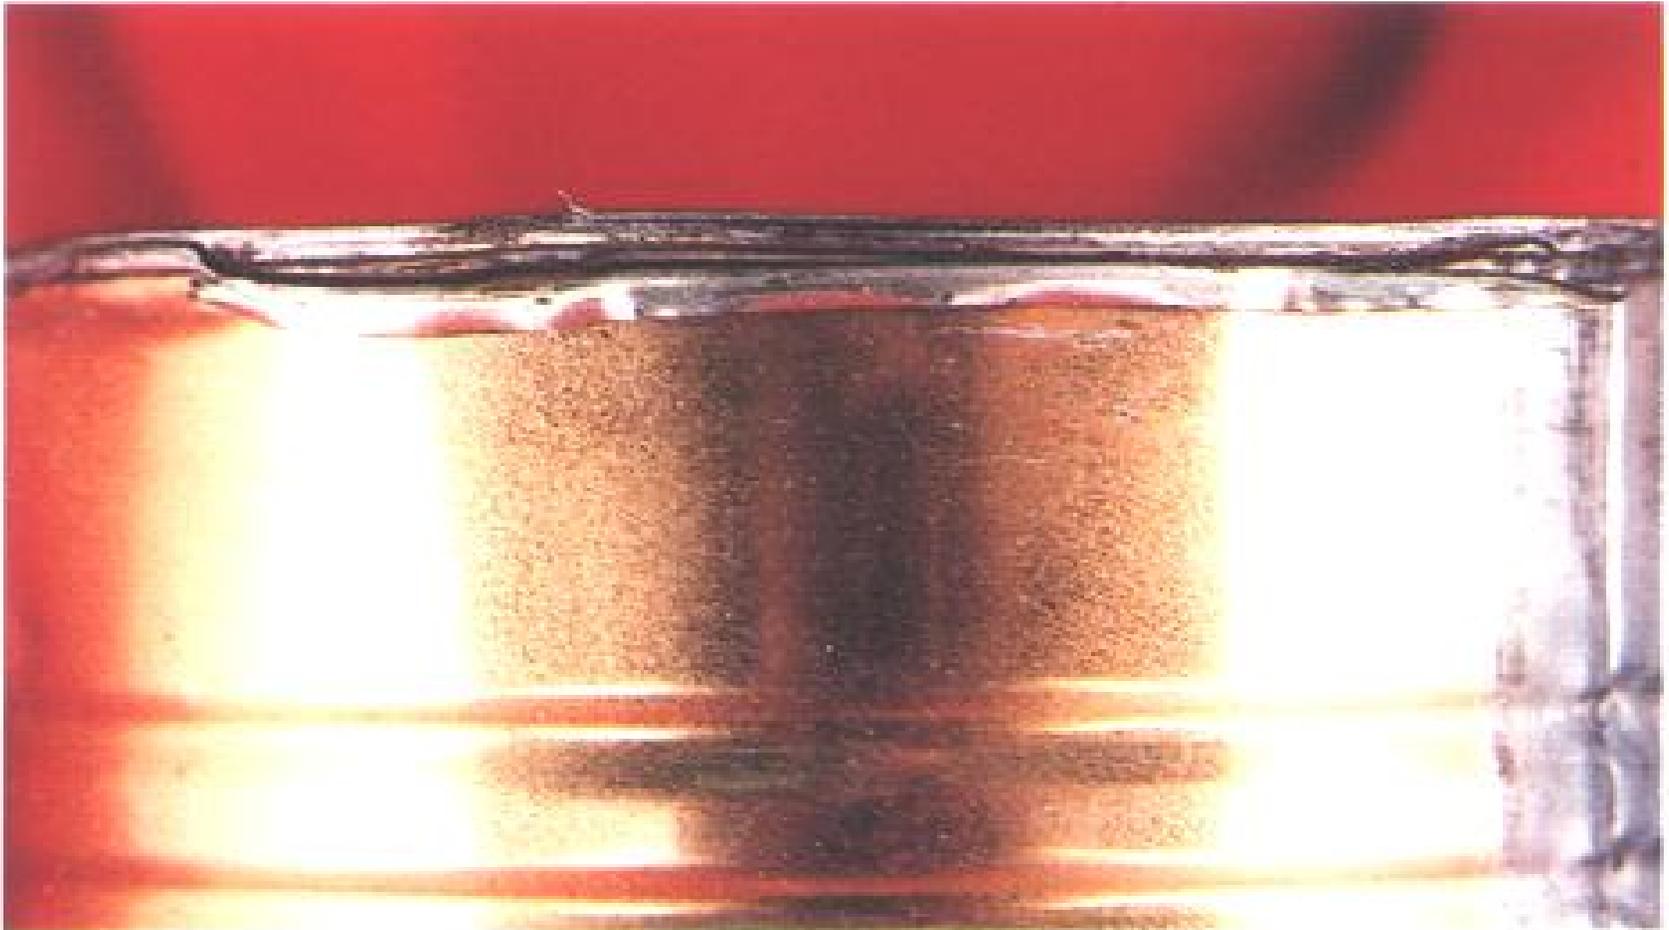
9.

Depicts a **false seam** with loss of hermetic seal. Seam is formed but not engaged properly. (Note knocked down flange).

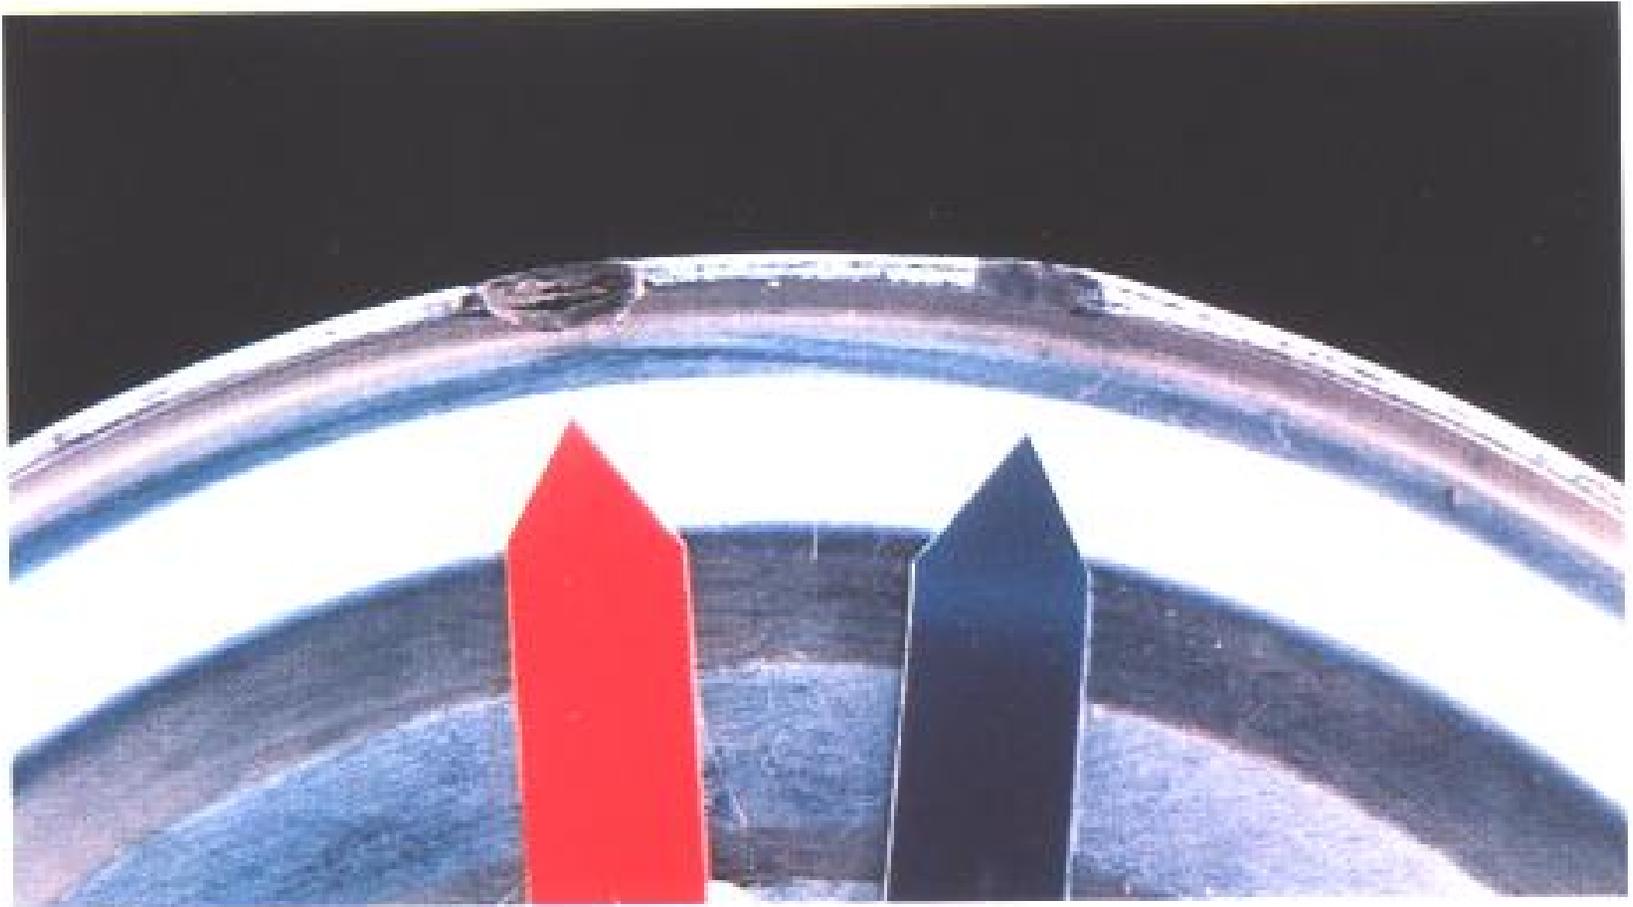
10.

Example of **cable cut** on can end. Red pointer shows "significant defect," i.e., cut through double seam. Blue pointer depicts cut/abrasion not through double seam.

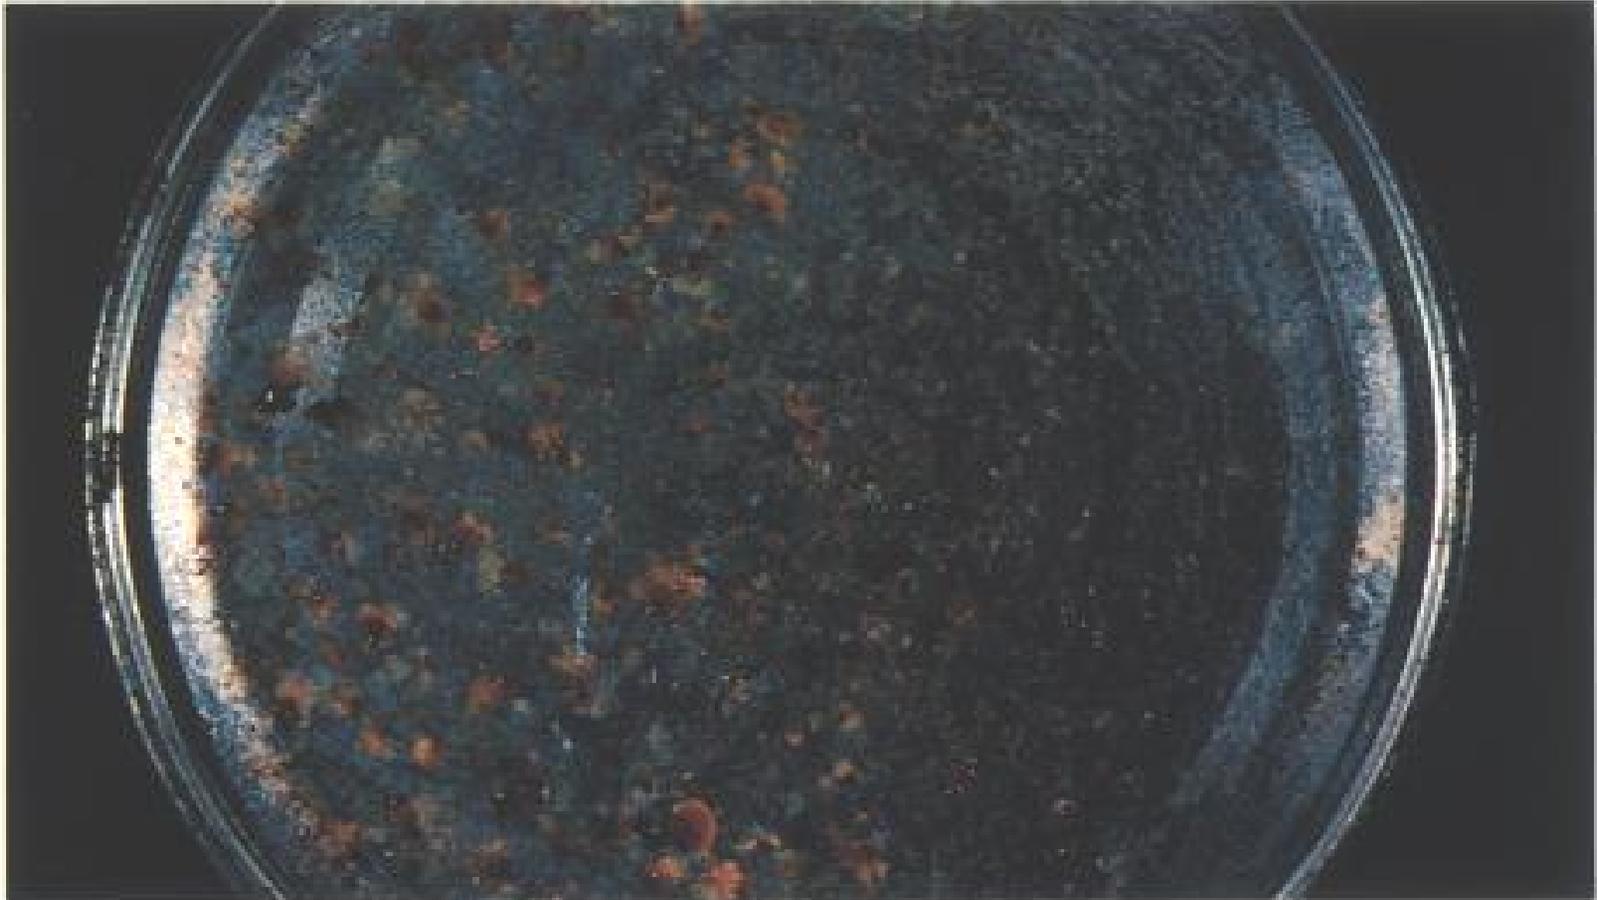
11.

Severely rusted with deep pits near point of perforation.

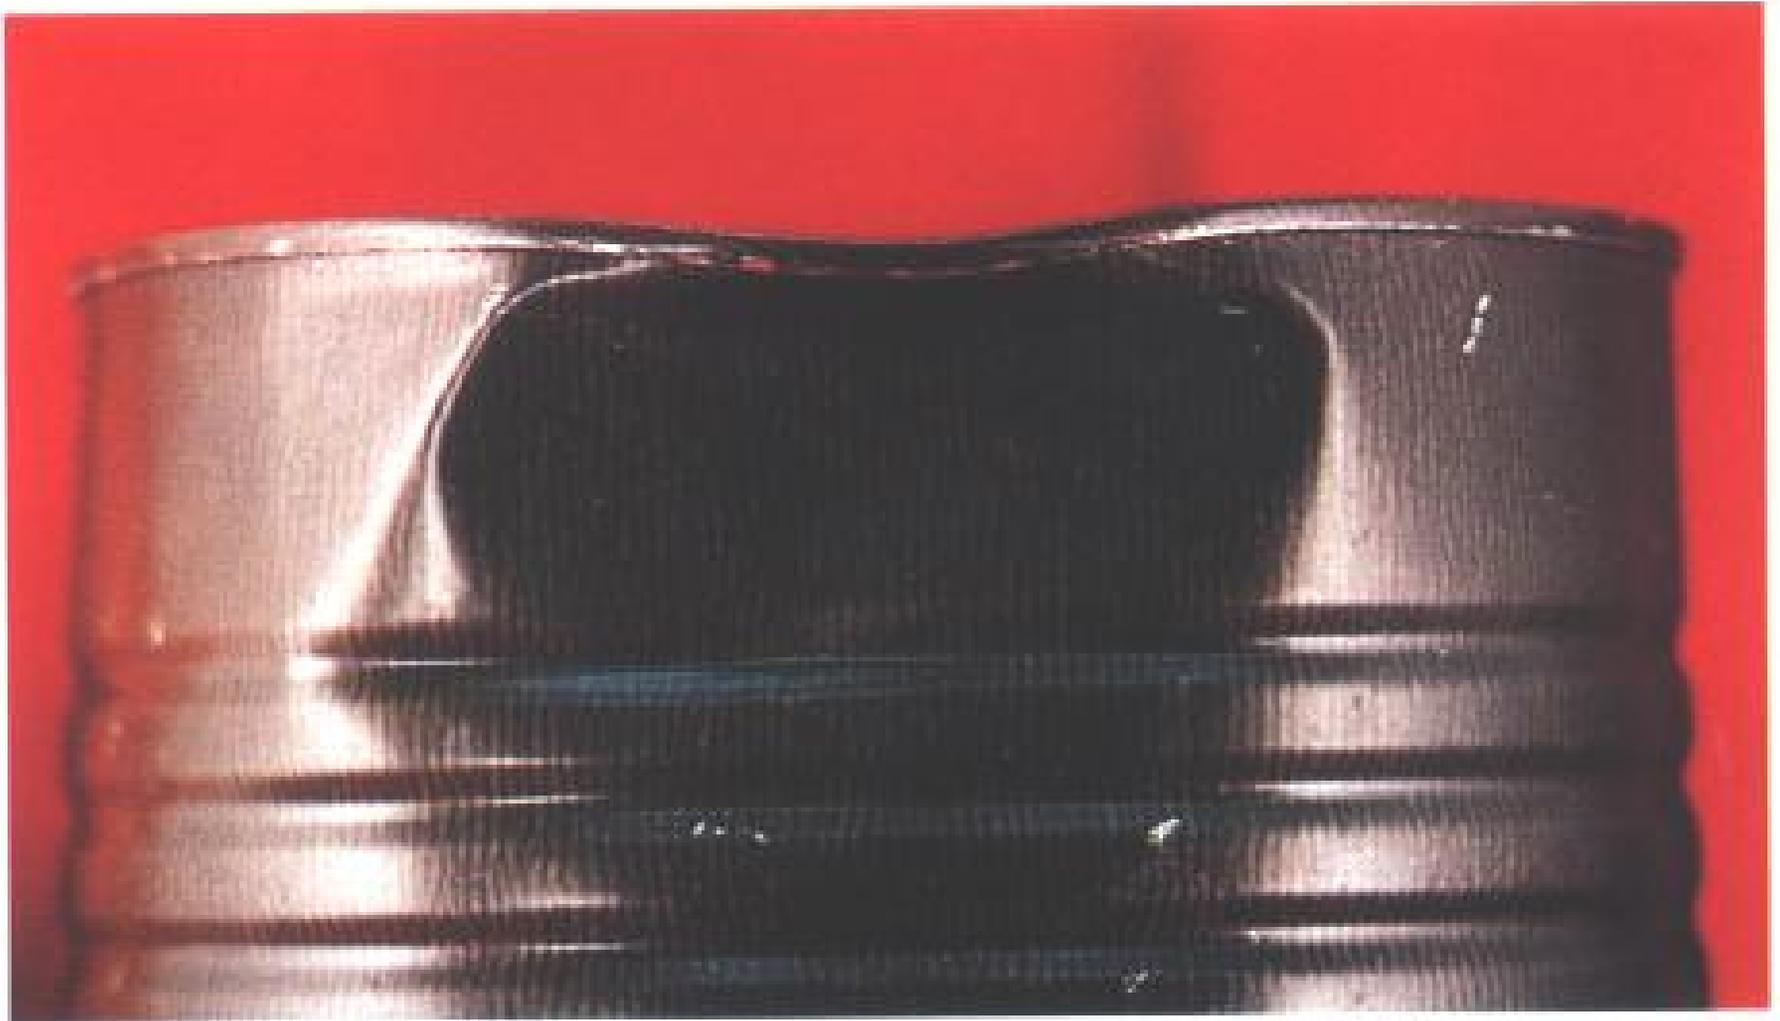
12.

Major body dent which has impacted on double seam. (Plate may be fractured with loss of hermetic seal).

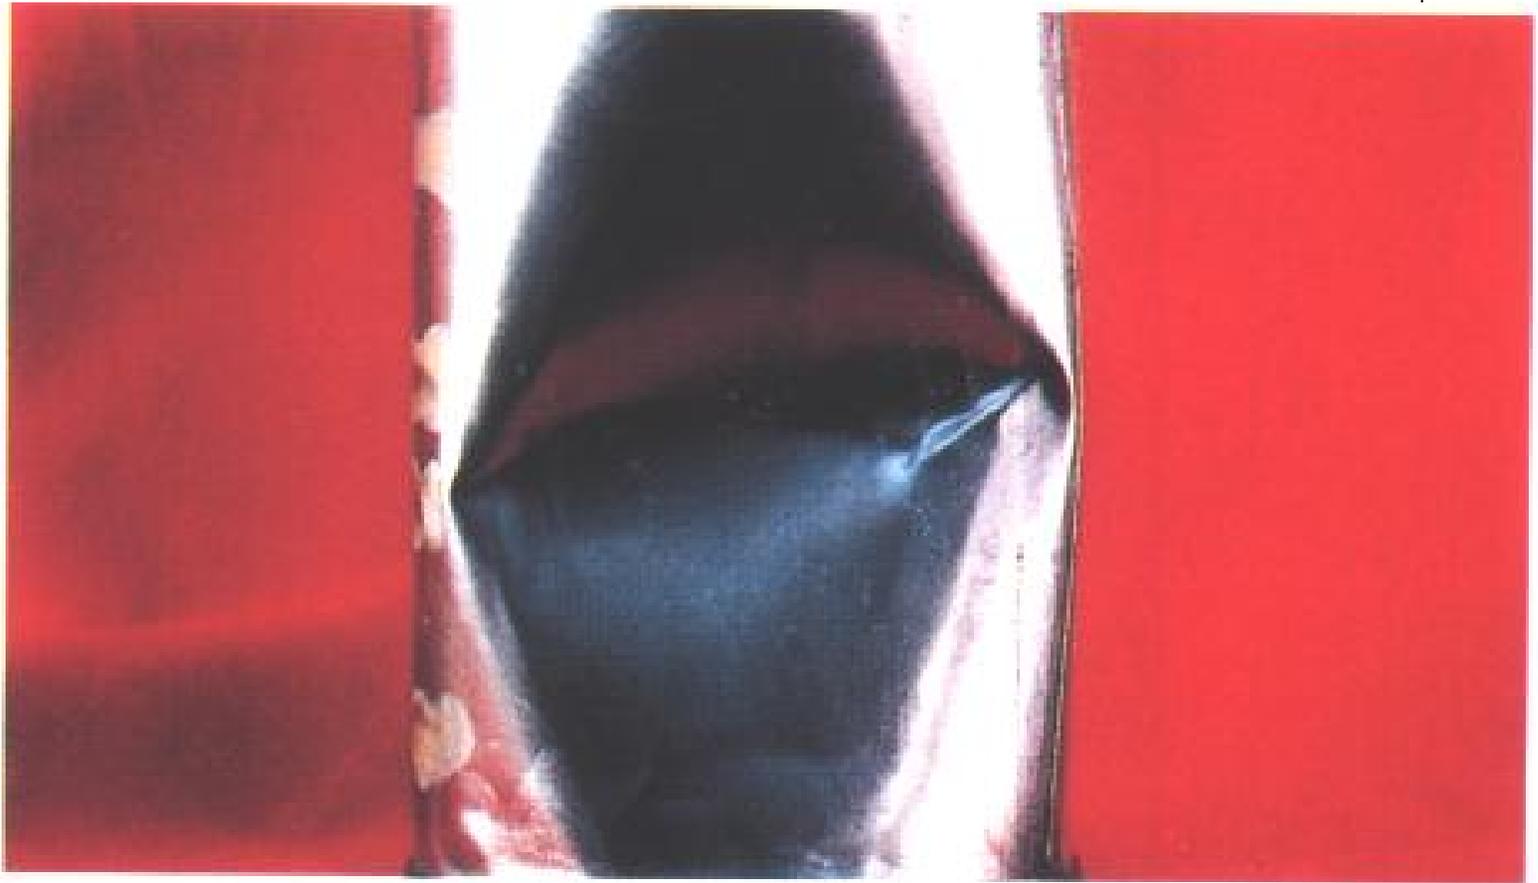
13.

Major dent in center of can body. (Plate may be fractured with loss of hermetic seal).

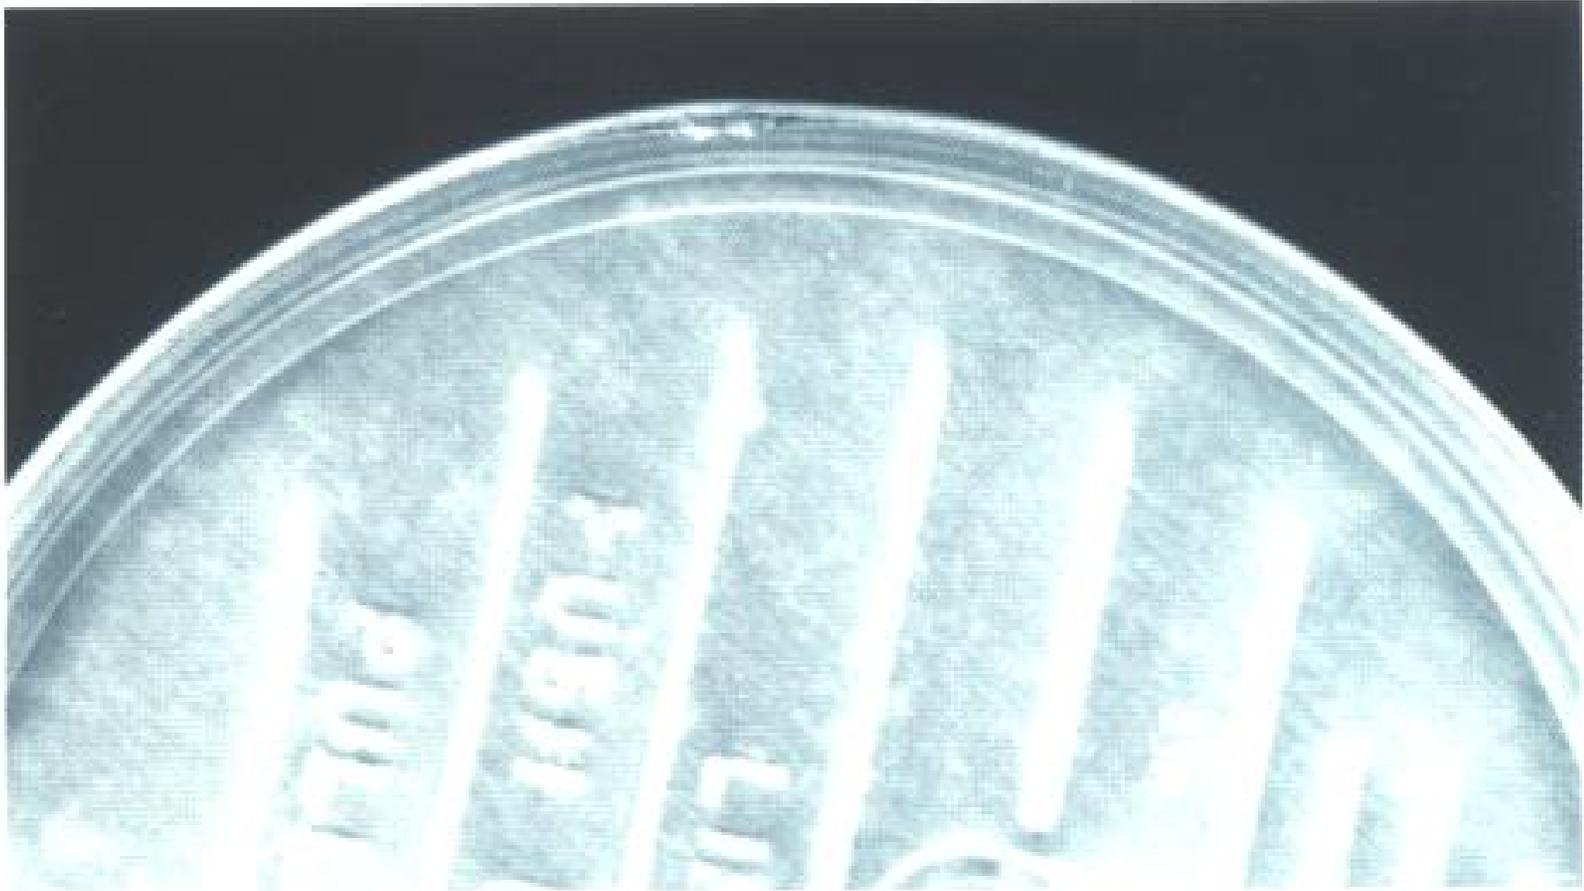
14.

"Cut-over" depicting sharp seam. (Observe for potential plate fracture or loss of hermetic seal).

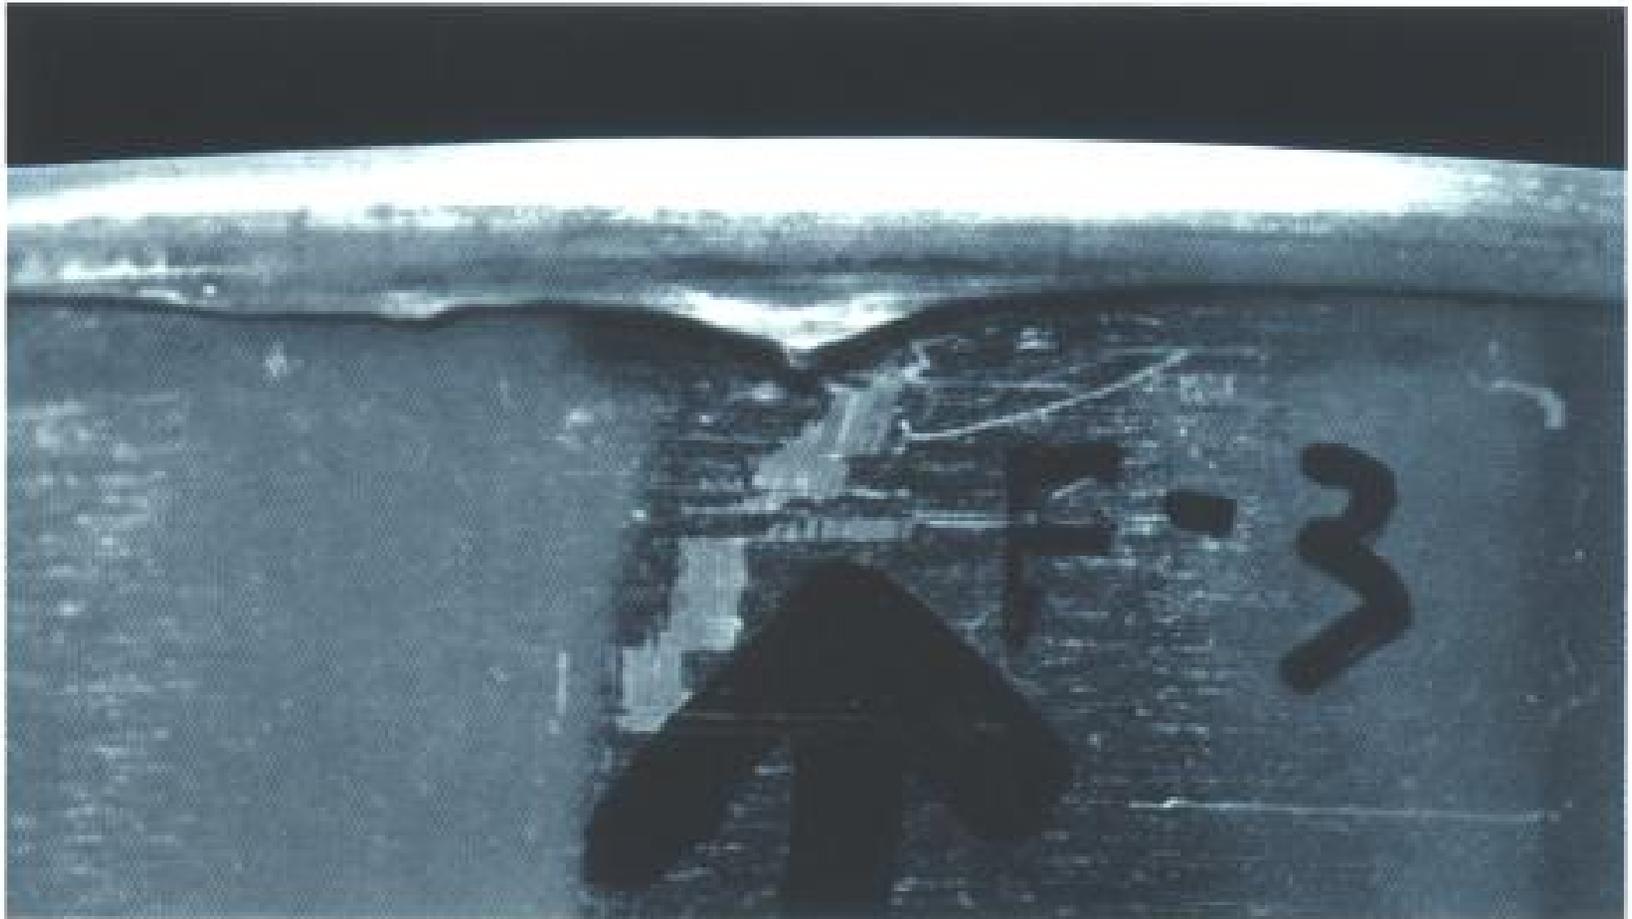
15.

Defect shown termed a "vee" or "spur" with end curl knocked down. Can be a potential leaker.
