# Can Defects

Examples of damage to metal cans  
and when damage requires return of  
merchandise.

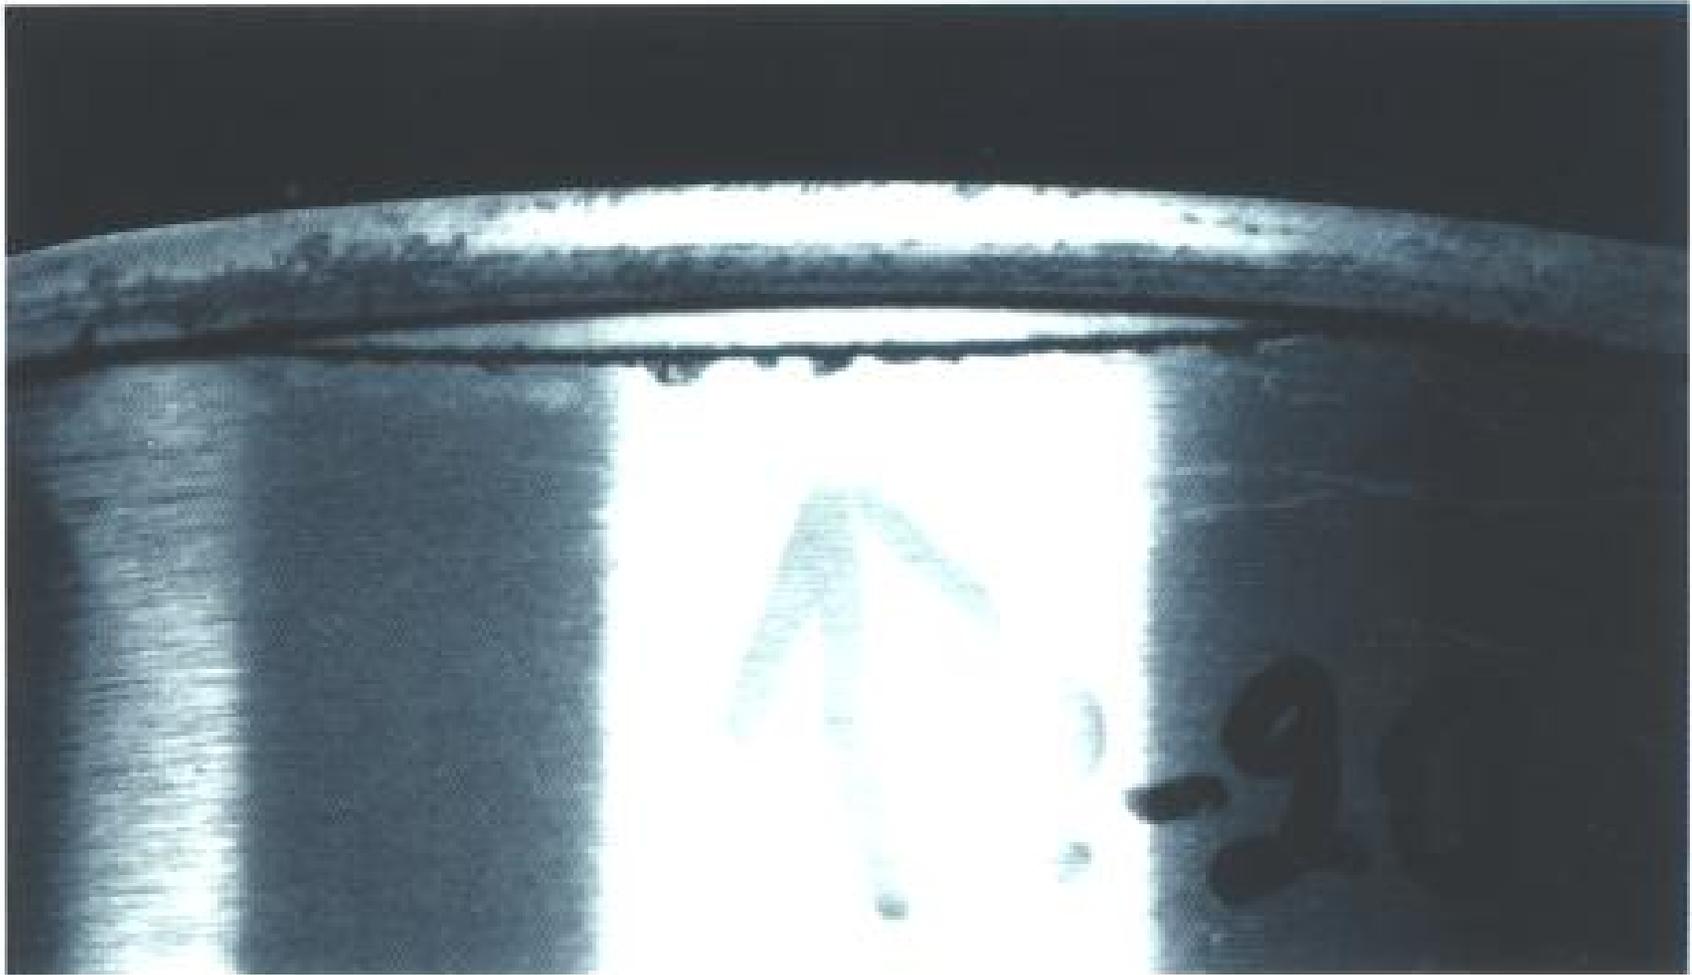
16. Pointer indicates "knocked down flange."

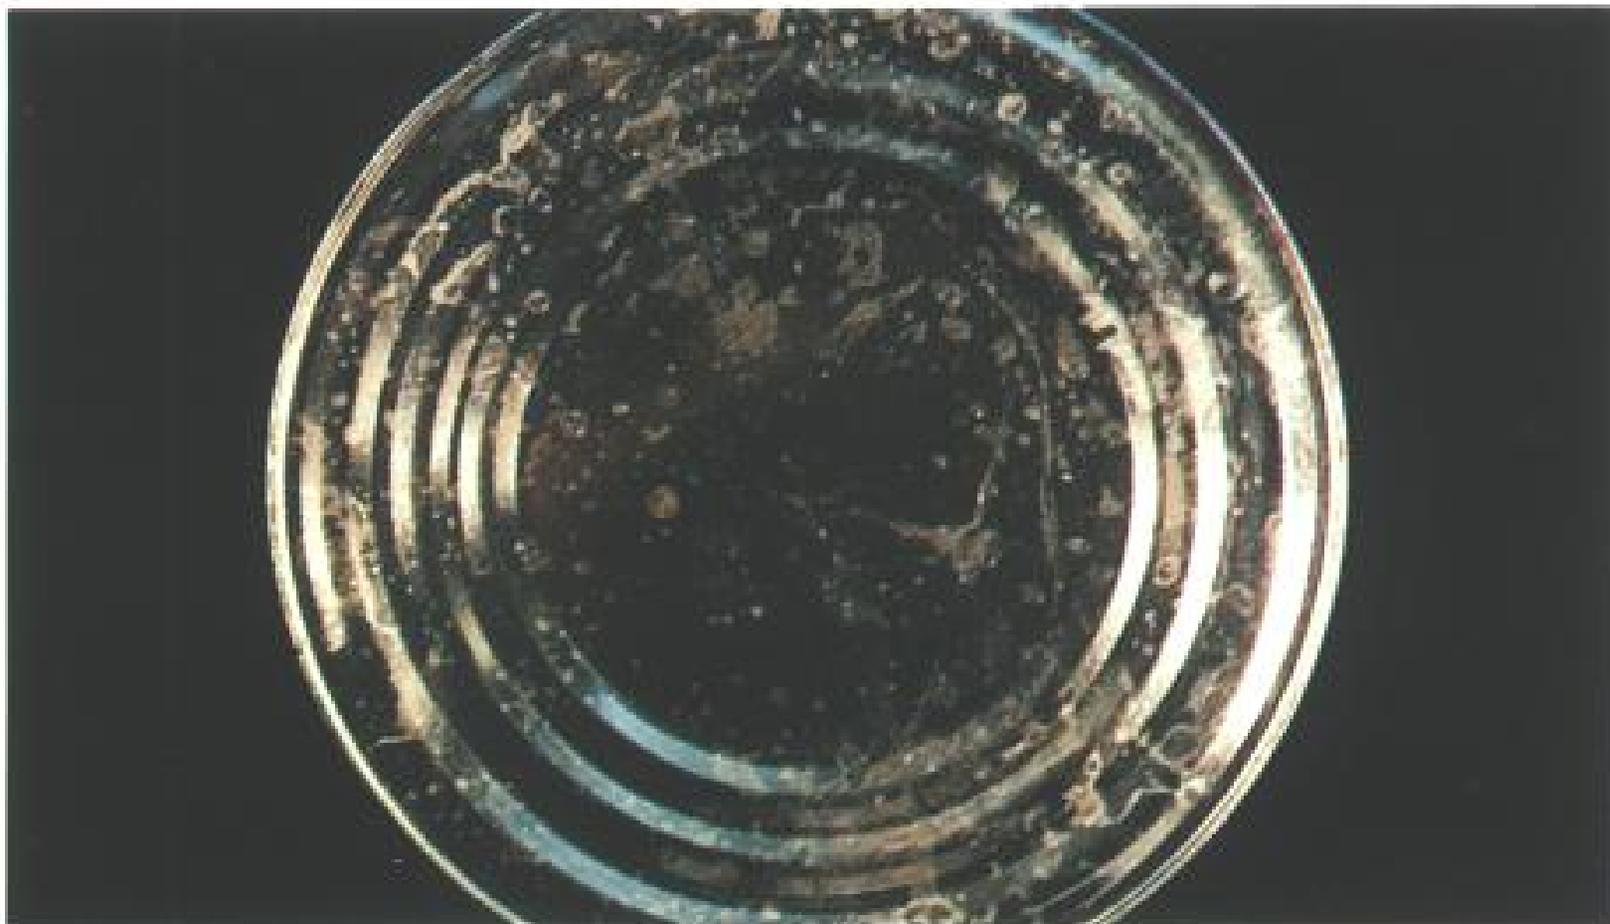
17.

Surface rust and residue food cooked on end of can. (Minor external rust and light superficial pitting easily removeable by light buffing is considered an insignificant defect).

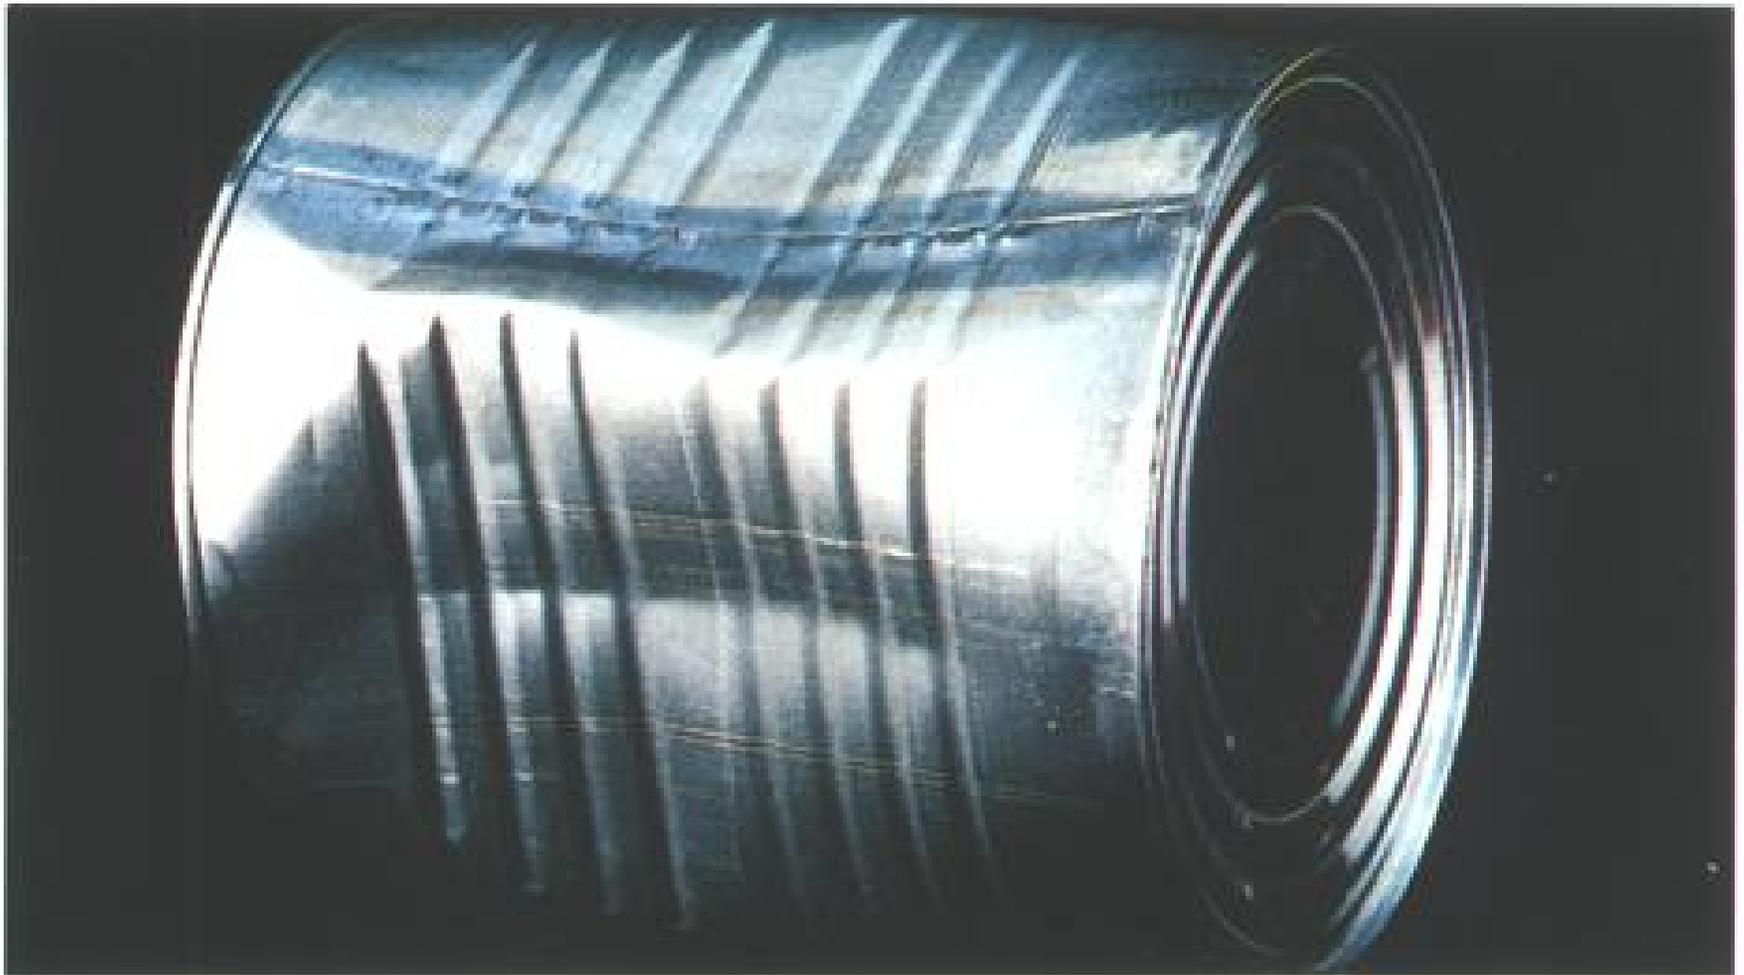
18.

Paneled container without visible signs of loss of integrity, i.e., no plate fractures.

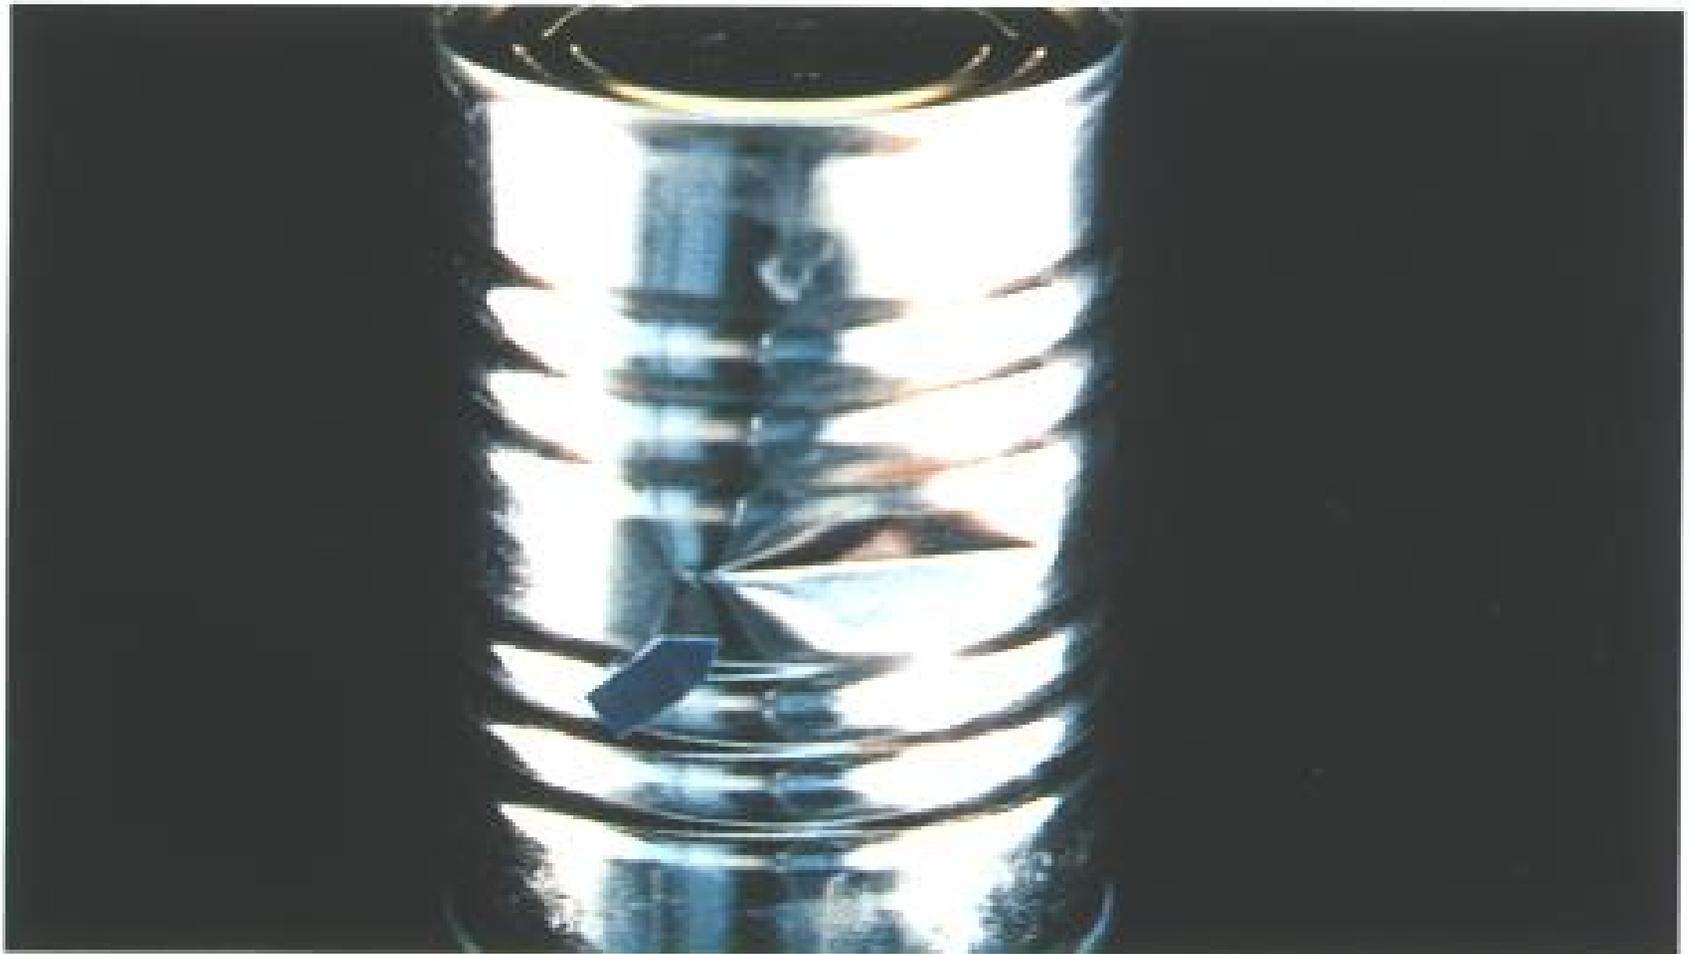
19.

Obvious body dent on side of container body. Side seam and/or double seams appear not significantly affected.

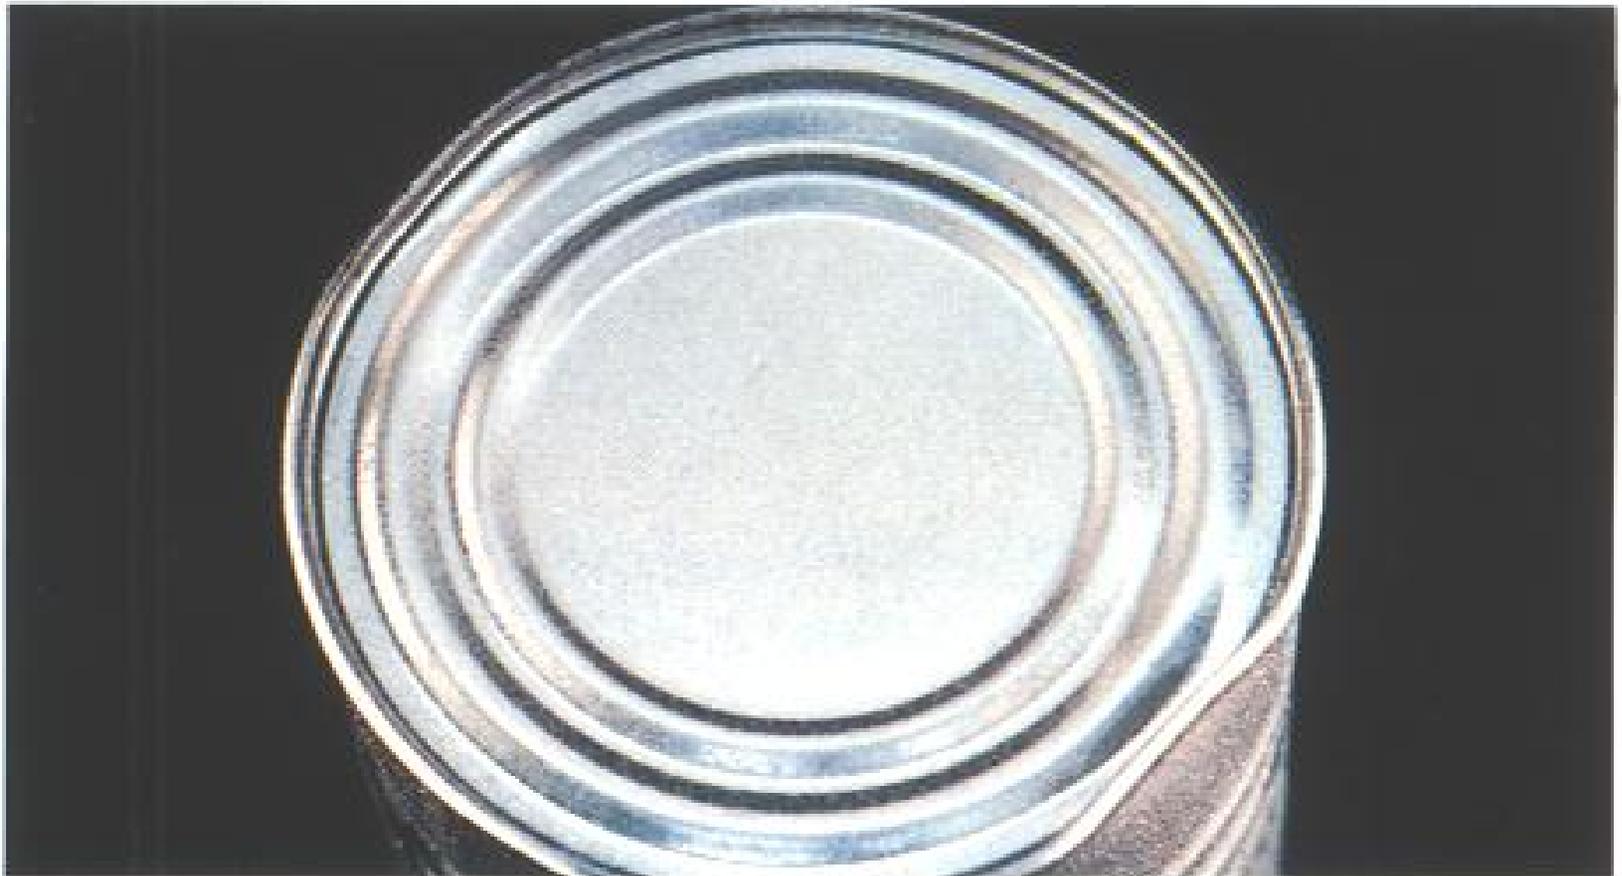
20.

Minor dent to double seam on end of can body, i.e., it does not appear creased or sharp.

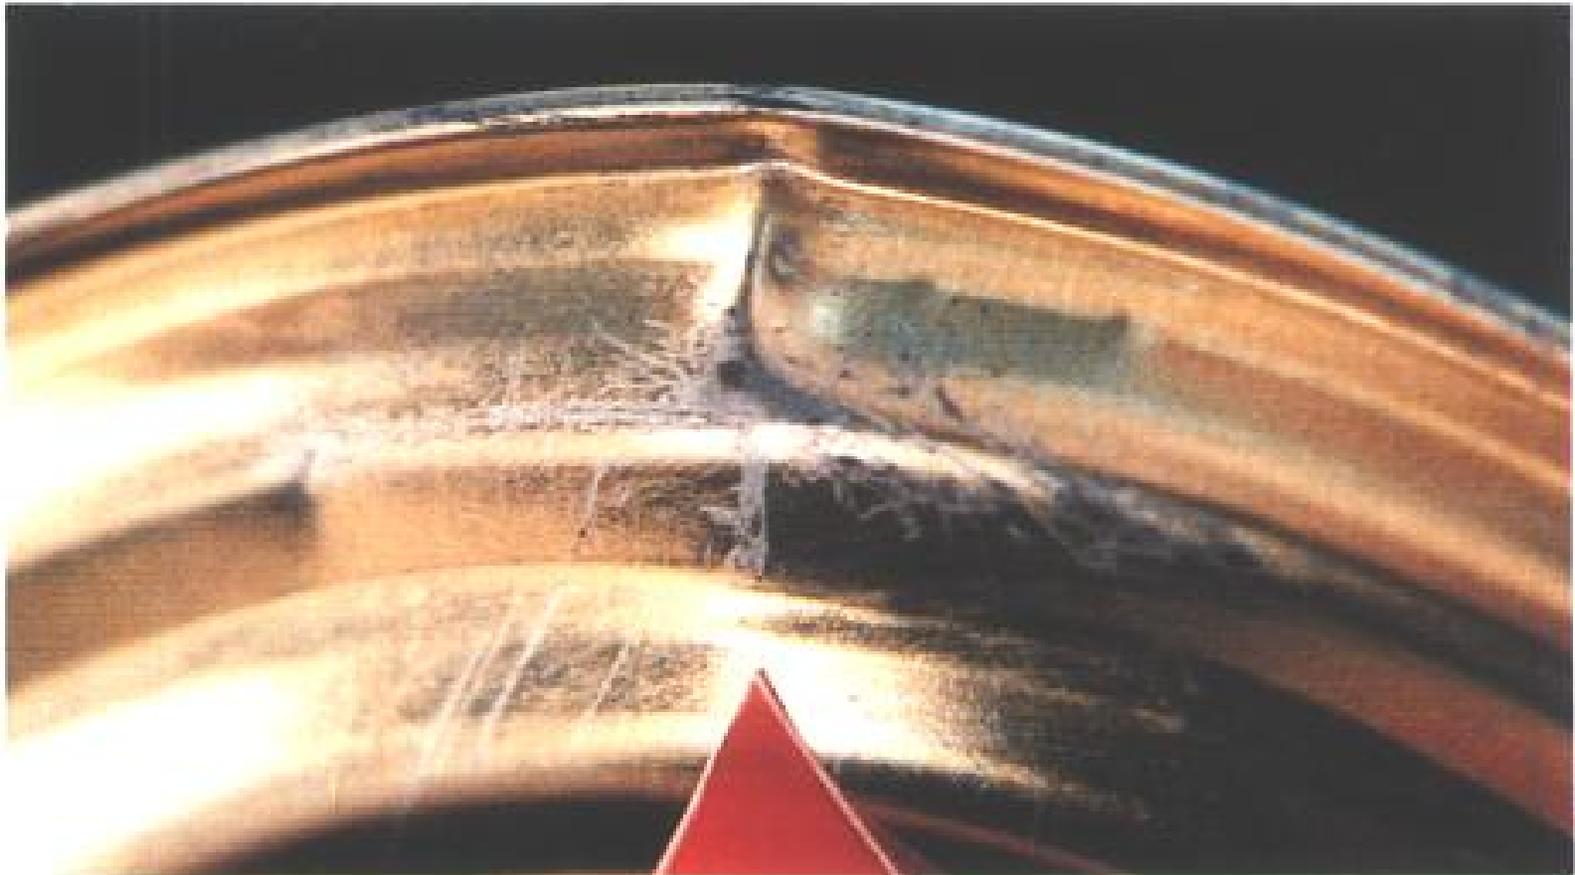
21.

Minor "buckle" just extending into double seam on end of can body. (Double seam does not appear significantly affected.)
